PART TWO: OBSERVATIONS & TREATMENT RECOMMENDATIONS

EXTERIOR CONDITIONS CHURCH

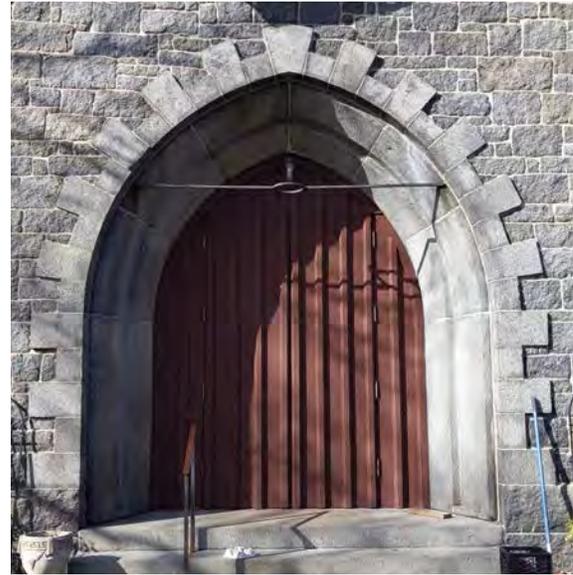
Image 01: The tower's ceremonial entrance, recessed in a stone archway and made of a board-and-batten wood design. Note the missing lantern from the iron bracket.

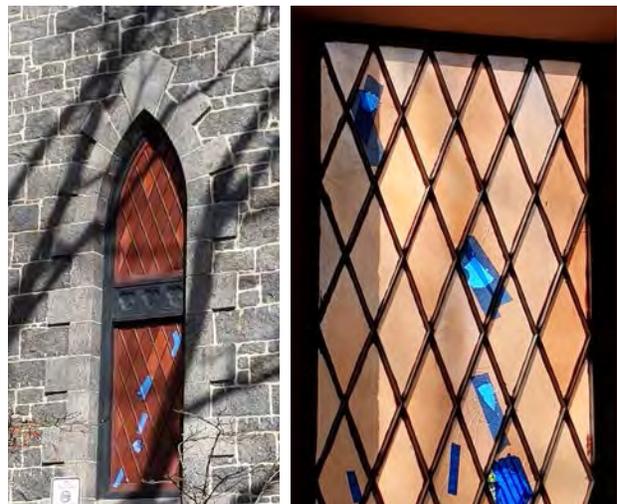
The lower half of the first floor lancet windows in the tower are visible at this level; the upper half visible from the organ level. They are diamond-patterned and made of wood, with wood muntins and “flesh”-colored lites. These windows were restored in previous phases of work, but glass has been broken and patched with painters tape [Image 07].

Image 07: ‘Flesh’ colored glass panes in the previously-restored lancet windows are subjected to wind-swept debris, or target practice.

- Replace the broken panes of 'flesh'-colored glass in the lancet window; consider protecting the exterior with a wire mesh panel, similar to the sanctuary windows.

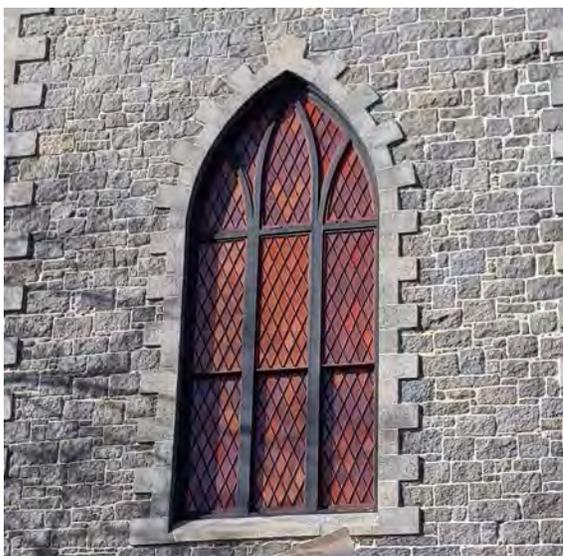
Image 10: The previously-restored large lancet window is in good condition, with some signs of peeling paint.

- Repair the cracked granite sill at the large lancet window.
- Repaint the large and narrow lancet windows at the tower.
- Conduct a thorough investigation of wall construction at all walls and levels of the tower to determine any latent issues. Employ a lift and stone masonry specialist to select stones for removal and observation.

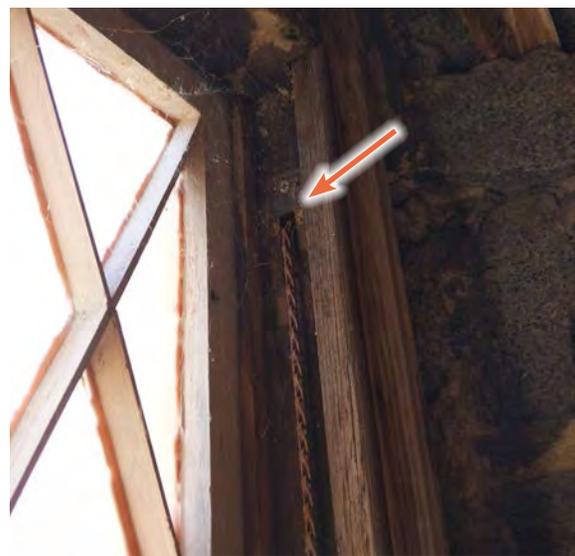
Image 11: The lower sashes of the large lancet window are hung with chains, but inoperable. The middle sashes may be fixed.

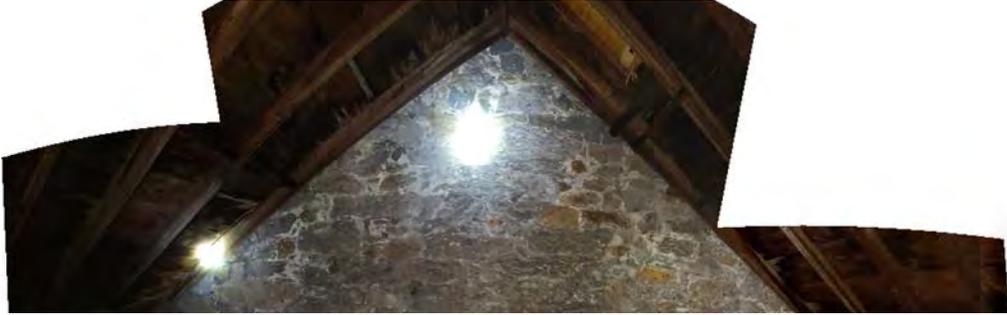
This 'attic level' provides the means accessing the sanctuary's 'attic' truss space. From this attic area, the rear (northwest, called west) side of the tower is visible from within the building. On three occasions this wall was observed on both dry and rainy days [Images 16-18]. Signs of water from the roof intersection above were present, and walls were damp to the touch. Although the masonry walls of the tower are in question, it is likely the deteriorated slate roof is the culprit. Conditions of the roof are discussed in a later section. A clever system of ventilation from the sanctuary was once routed through the long attic space and in through two oval, hinged panels that flank the tower [Image 19]. An abandoned wood-framed duct system is visible and vertically continuous from this level upwards to the belfry [Images 20-21].

Image 16: Rear (west) wall of the tower as seen from the church sanctuary attic. Here, the roof ridge meets the tower.

- Mitigate water infiltration at the roof-tower intersection by following the recommendations outlined in roof section, later in this report.
- Investigate the trim stones and their joints at the clock. Repoint and flash as required to mitigate water intrusion.

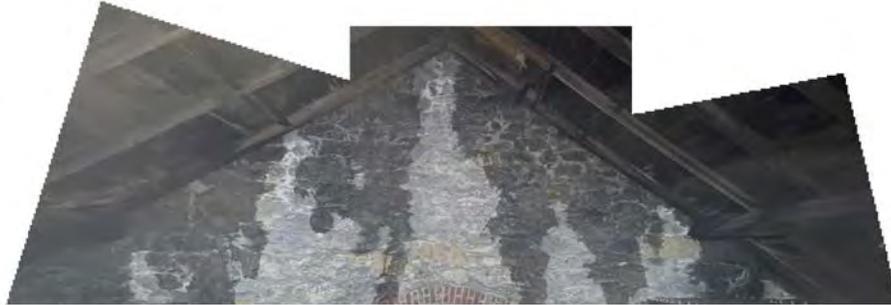
Image 18: A December 8th, 2020 rainstorm leads to another water infiltration event at the tower's west wall.

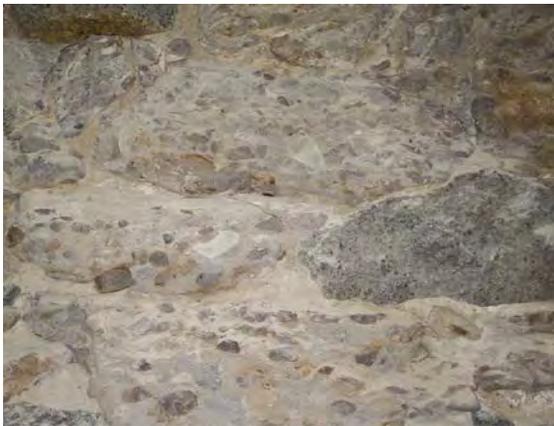
Image 26: The tower's Roxbury puddingstone shows off its array of smaller stones within, still "hard as a rock".

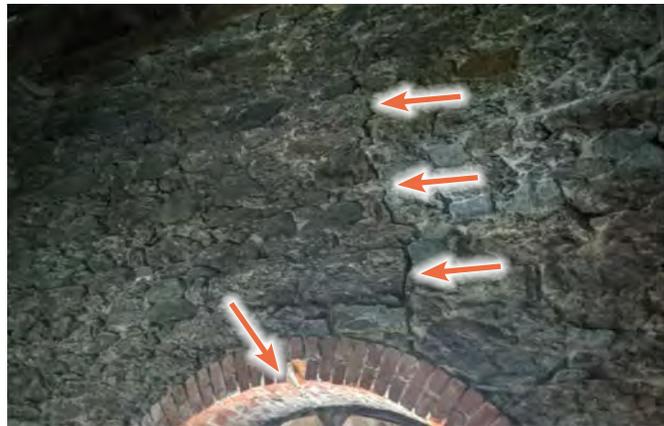
Image 27: Arrows indicate the lengths of cracking seen occasionally in the tower interior. Another arrow points to water intrusion at the clock's arch.

- Monitor lengthy cracks in the Roxbury puddingstone backup at all levels of the tower. Repoint as required after a thorough investigation of the masonry construction at all walls.

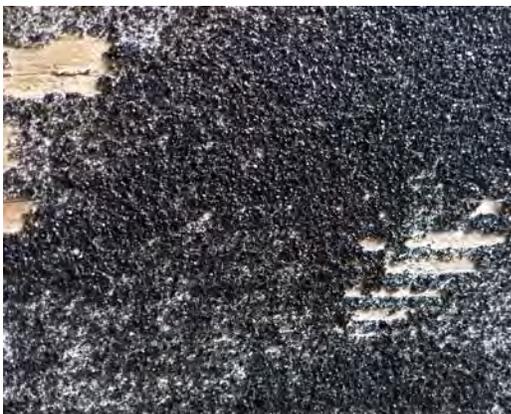
Image 28: 'Smaltz' is a fine aggregate of glass/sand used to give surfaces an unmistakable glitter.

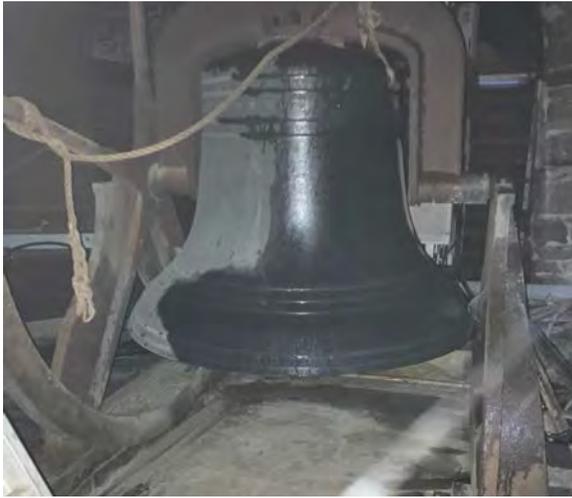
Image 31: The bell is subject to wind-swept rainwater from the louvers. A membrane floor drains back to the louvers.

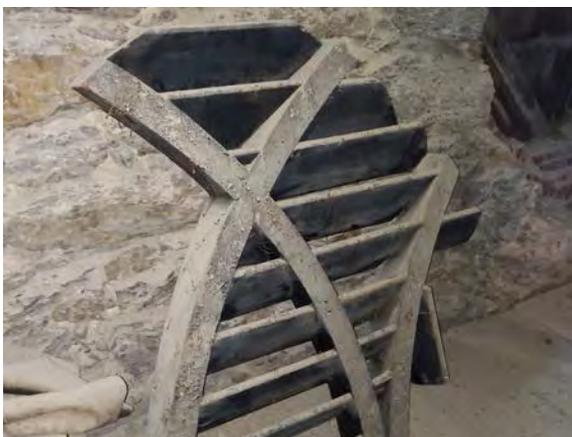
Image 33: The uninstalled wood louvers (replaced by fiberglass) take residence in corners of the tower, and should be protected.

- Protect the wood louvers stored throughout the tower levels.
- Repoint joints and replaced damaged brick at the interior louver archways in the belfry.

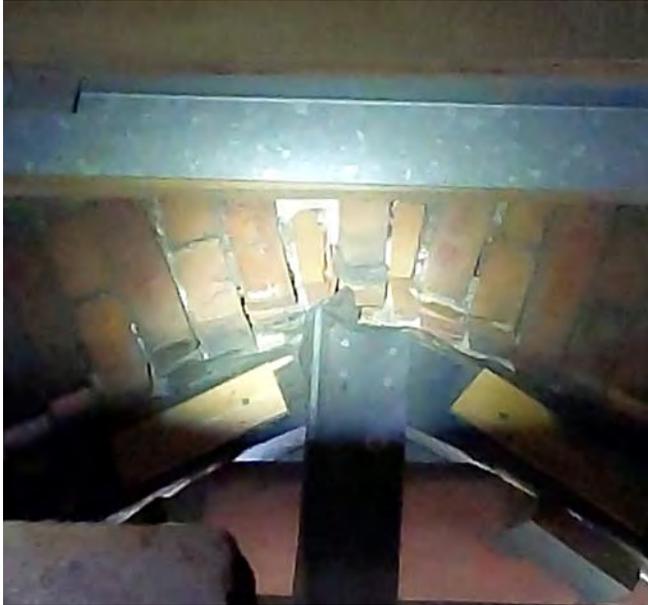
The above Belfry level contains a large cast bell, struck hourly by a hammer and controlled by the clock mechanism from the level below. In heavy wind-driven rains, the bell may be soaked with water from the louvers, seen on one site visit [**Image 31**]. This is expected, and the floor is covered in rubber membrane and canted towards the open louvers to facilitate water drainage. The rubber membrane floor was installed in previous phases of work that included the replacement of the original wood louvers with matching fiberglass and new sill flashings at the base of the louvers where water was thought to be seeping through. The north, east, and south louvers are all fiberglass [**Image 32**], presumably to ensure the cellular antennae equipment behind each is unimpeded. The uninstalled louvers are stored in parts, scattered among the lower levels of the tower [**Image 33**]. The west (rear) louver has no equipment adjacent to it, and is still made of wood, either partially original or replaced in the 20th century. The interior masonry condition is similar to the levels below, with fair conditions of mortar. The worst is at the joints of the brick arches seen at a few louvers, where the mortar is severely deteriorated [**Image 34**].

Image 34: Deteriorated mortar at the brick arches of the louvers are in varying conditions. Here, former water infiltration washed much away.

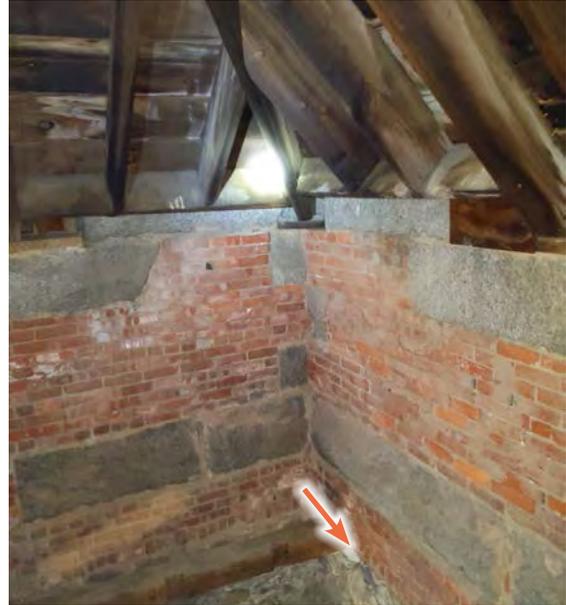
Image 35: An arrow indicates the demising line of the original tower wall and its reconstructed section above.

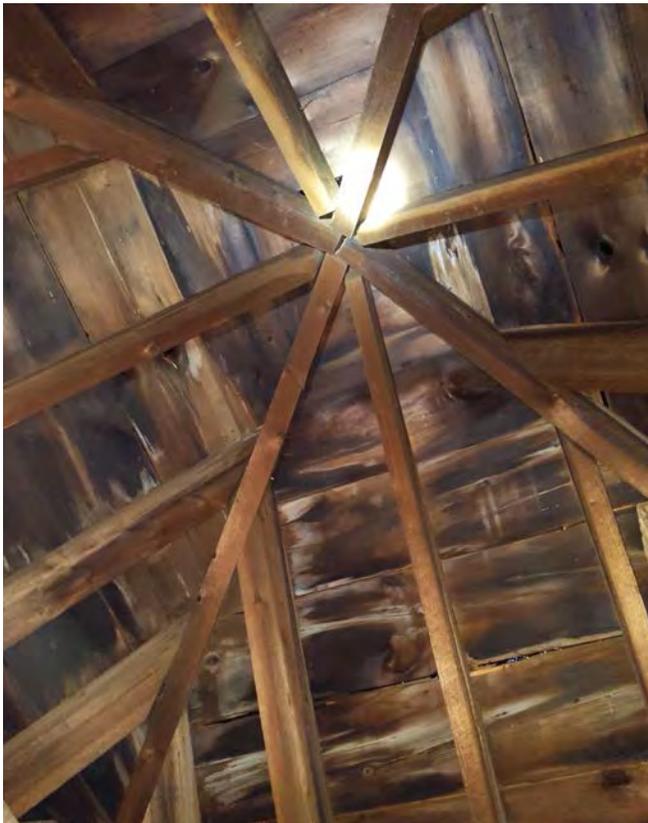
Image 36: The tower's wooden rafters and sheathing are dry and dense. Discoloration stems from moisture before the new roof in 2012.

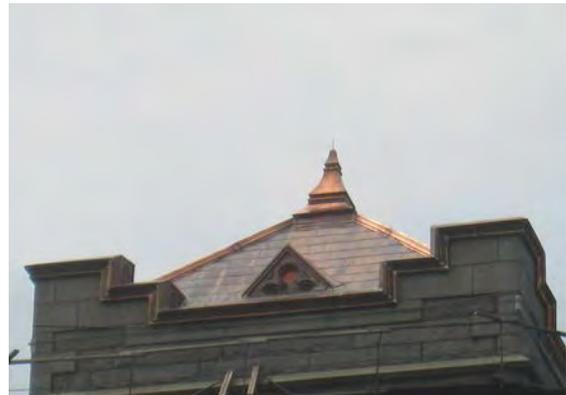
Image 37: Photo from 2012, showing the new copper roof, tight as a drum today.

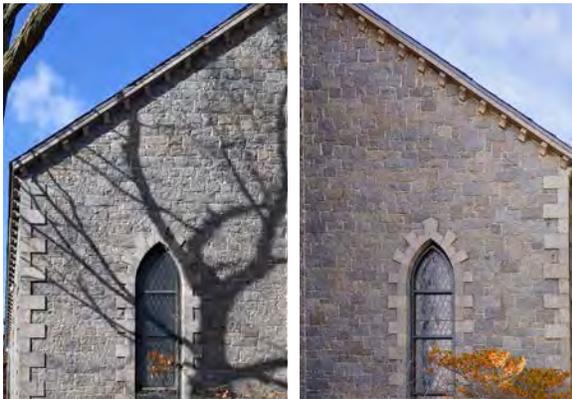
Image 39: The stone and mortar is in fine shape at the south gable walls, with many decades of service to come.

The two southeast/east ashlar granite walls that flank the tower **[Image 39]** were repointed in the early-2000s. Twenty years later, these walls and trim stones are in excellent shape - a testament to how proper mortar formulation and repointing technique is critical. The granite sill at the right tower-flanking window is cracked and should be repaired.

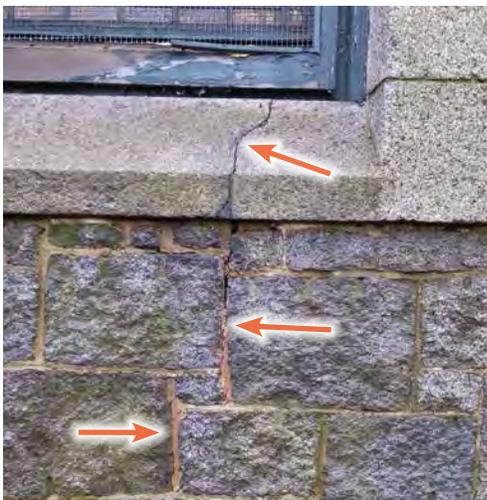
Image 41: An occasional cracked granite sill and mismatched mortar repairs are easily detected.

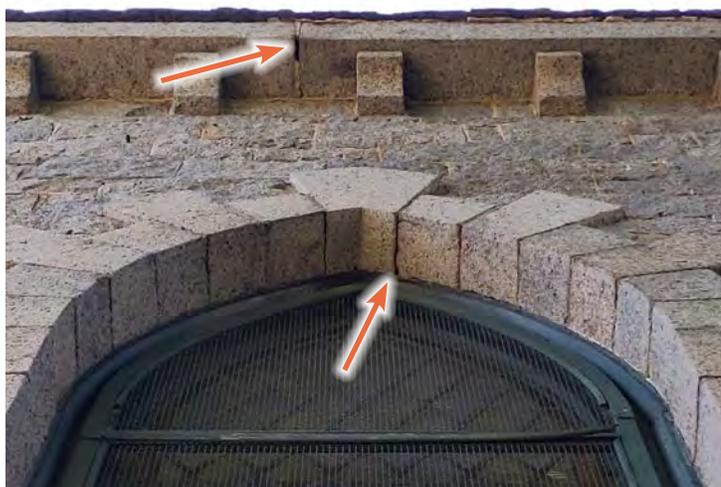
Image 42: When in doubt, just look up: deteriorated joints at the window voussoirs and missing mortar at the eave stones are a prime spot for future leaks.

- Repoint 100% of the masonry (foundations, watertables, ashlar granite, and trim) at the following elevations: north Eliot street façade, west gable wall including apse, and south wall.
- Clean all paint-stained granite sills.
- Repair the cracked granite sills.
- Investigate the voids found at the deteriorated west wall at the sanctuary and apse.
- Repoint the rubble granite foundation along the south façade.
- Clean the dark stains from the dressed quoins, at both corners of the southeast gable wall.

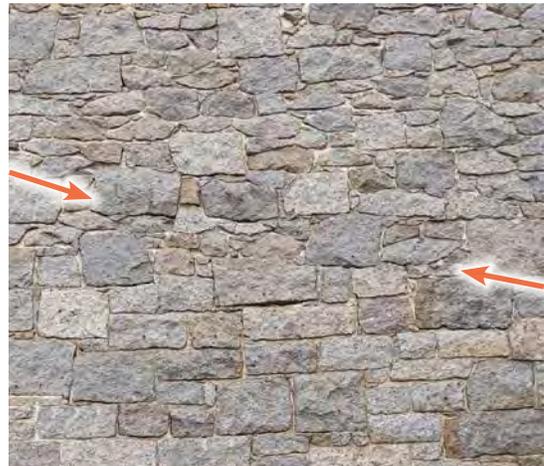
The rear (northwest/west) elevation of the sanctuary is constructed with two differing cuts of granite: the lower half with quarry-faced ashlar granite (seen elsewhere), and the upper half with uncoursed granite fragments, likely to save cost at the least-viewed facade [Image 43]. The ashlar granite is seen best near the parish hall's Eliot Street entry, where weathered mortar has become recessed and chipped [Image 44]. The uncoursed upper granite is best seen by climbing onto the flat roof and up the valleys to the sanctuary's rectangular apse [Image 45], now enveloped by the 1889 parish hall addition. The mortar at both sanctuary and apse walls is heavily worn, where joints and small stones can be pulled by determined fingers to reveal voids behind [Image 46]. Although this elevation is seen less than the others, the wall here serves as the interface of church and parish hall and should be considered a high priority for repointing.

Image 43: A keen eye will notice the subtle change in granite stones at the rear wall: ashlar below, and rubble above. Church stewards and builders were wary of cost in 1883, just as today. Arrows demarcate the gradual transition.

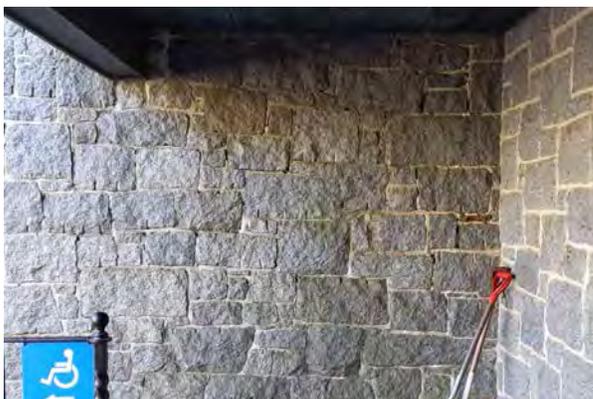
Image 44: Ashlar granite joints are clearly deteriorated at Parish hall's Eliot Street entry.

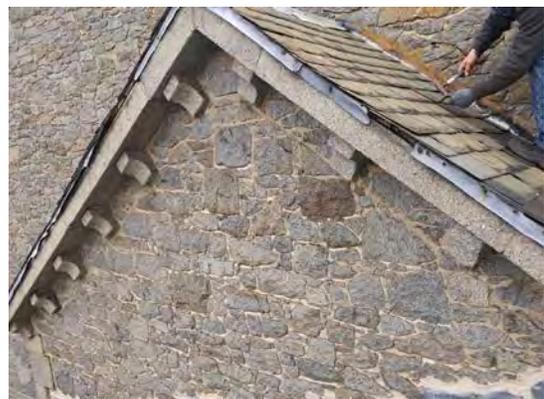
Image 45: The apse (now surrounded by the parish hall) was constructed similar to the church's gable wall.

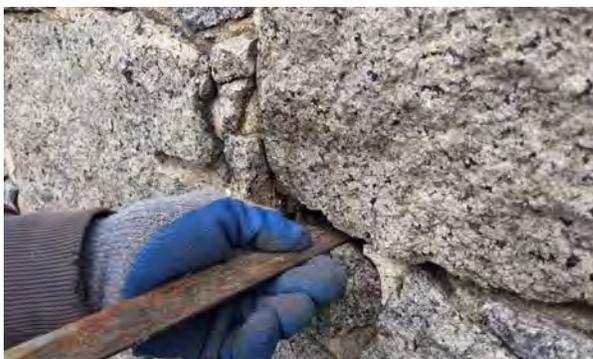
Image 46: Loose mortar and small stones are easily pried from the west gable wall. A slater's tool serves as an impromptu measuring device to show how deep some voids in the wall go. Fortunately, no residents.

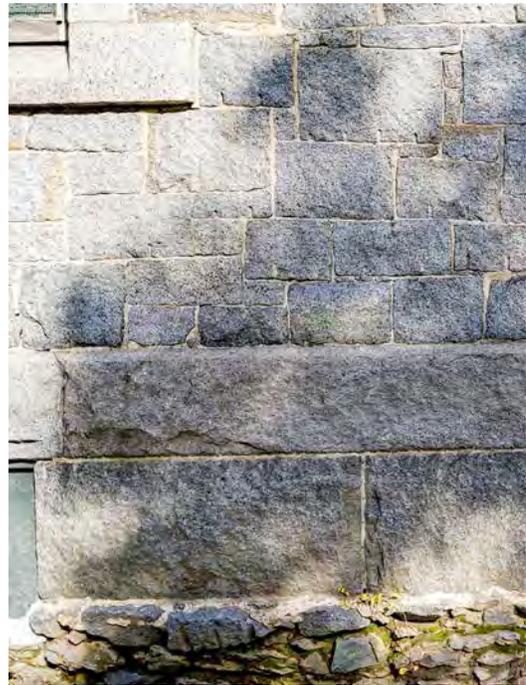
Image 47: Four types of stone on display at the south wall, with varying degrees of mortar deterioration.

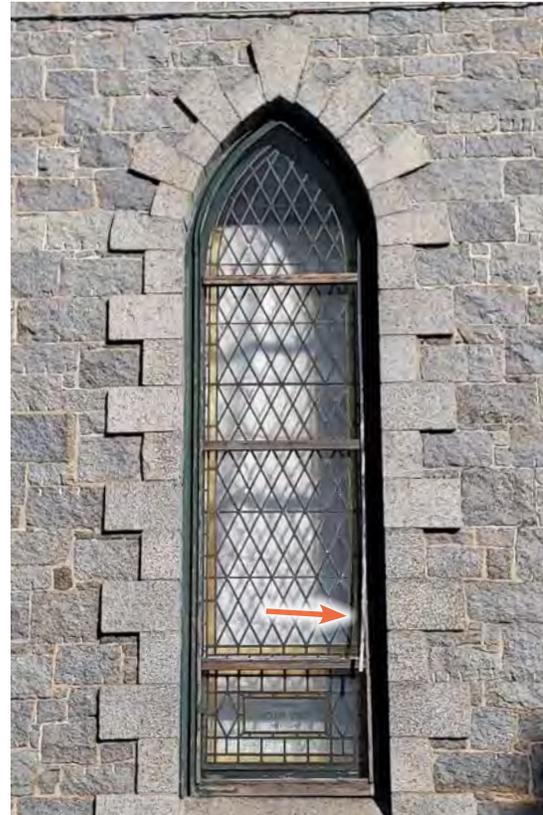
Image 50: A deteriorating wire mesh cover has otherwise protected its window very well since first installed.

- Repair any broken wire mesh window covers and repaint to match windows.
- Restore deteriorated leaded glass windows, identified and elaborated on in the *Stained & Leaded Glass Windows Report*, and repaint sash frames.
- Restore the wood sash trefoil window high on the west gable wall.
- Monitor and repaint lower level window coverboards as needed to maintain.

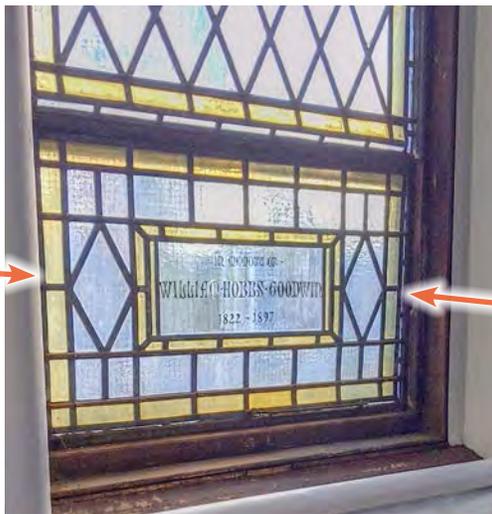
Image 51: A leaded-glass window bears commemorative inscriptions. Arrows show the pivots for ventilation..

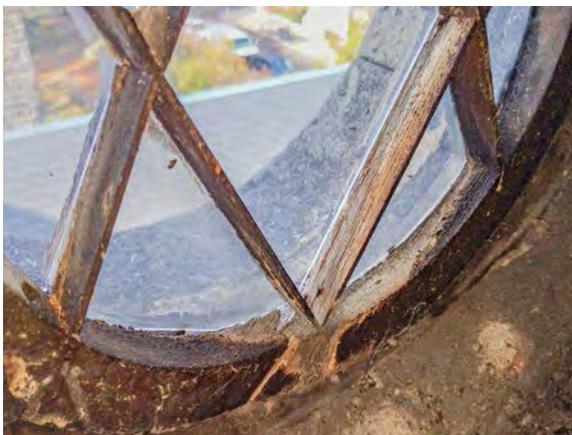
Image 55: Time has taken its toll on the wood sash and muntins of the trefoil window.

One trefoil window peers out from the top of the sanctuary's west gable wall, lined with dressed trim stones [Image 53]. Like the tower lancet windows, it is a wood sash with wood muntins arranged in a diamond pattern. The sash is fixed by a few thumb-turns on the inside, reached by traversing the attic space above the sanctuary [Image 54]. Glass lites are broken and missing, the sash and muntins are deteriorating [Image 55]. The window should be carefully restored, being one of the building's most charming features.

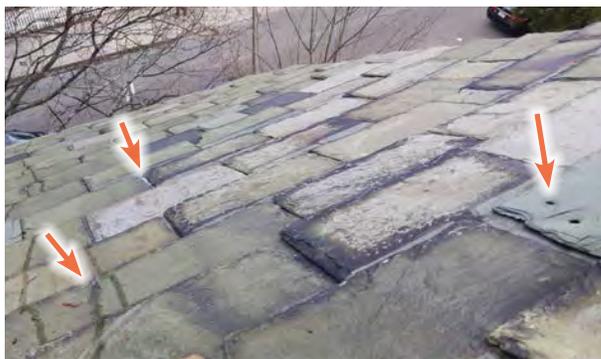
Image 60: Arrows show only a few of the many holes and slate repairs, including a glob of sealant between slates (bottom-left).

- Repair the roof truss as outlined in the *Structural Report*. Investigate the flatness of the sheathing during roof replacement.
- At the nave: replace the slate roof entirely with Vermont 'Unfading Green' slate. The slate on the apse would be replaced at the same time, ideally.
- At the nave: replace ridge caps, and copper-clad roof hatches.
- At the apse: provide new ridge cap, edge flashing, step flashing, and higher lead counter flashing.
- Install mesh screen inside the attic at the gaps between rafters by the eaves.

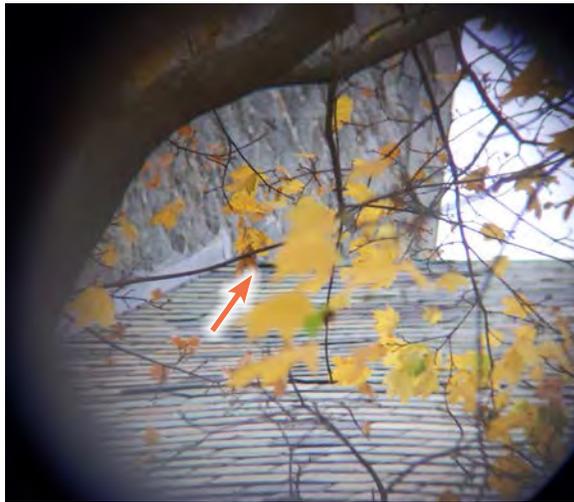
Image 62: A state-of-the-art device (phone stuck to binoculars) captures the hidden, warped ridge cap by the tower.

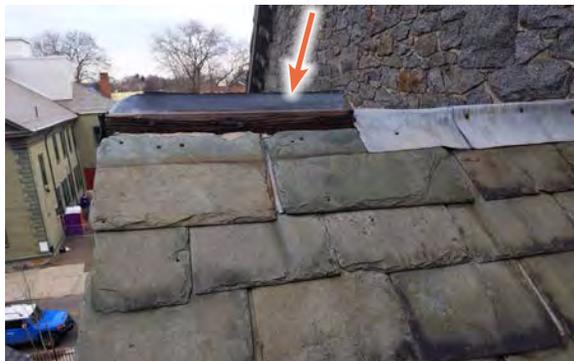
Image 63: This completely absent ridge cap on the apse is a major source of possible water intrusion.

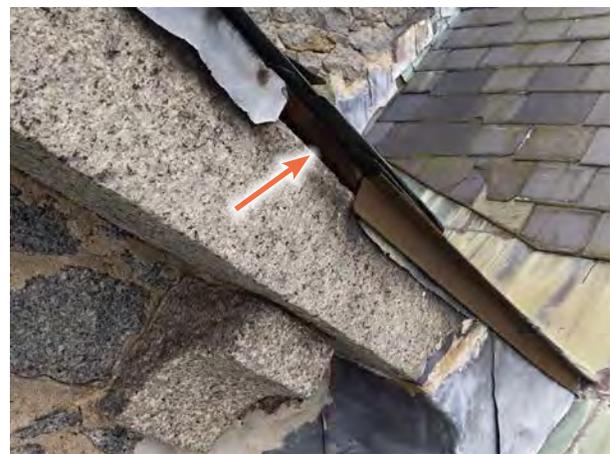
Regularly-soaked board sheathing during heavy rains can be seen where the sanctuary roof intersects the tower's west wall, insofar that the masonry wall inside is washed with water [Images 16-18]. This is not helped by the deteriorated ridge caps warped by the tower wall [Image 62] or missing entirely at the apse [Image 63]. The early-2000s repointing project of the east gable walls included flashing at the raking stones on the east [Image 64] and west gable walls of the sanctuary. Both continue to function well, although the connection between the old ridge cap and newer edge flashing at the west gable is questionable [Image 65], best fixed with new a ridge cap. A half-hearted installation of edge flashing at the raking stones of the apse roof results in exposed, damp board sheathing [Image 66].

Image 66: A discontinuous edge flashing at the apse's raking cornice exposes damp sheathing.

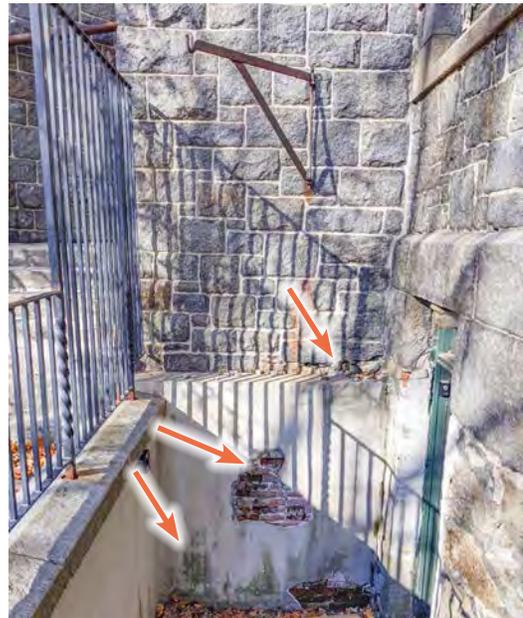
Image 72: The areaway stair walls are damaged and stained with from the collecting water and snow.

- Clean the bottom landing of all dirt and debris. Inspect and dislodge blocks in the floor drain.
- Clean stains and organic growth from walls.
- Repair the deteriorated parge coat on brick wall and damaged/missing stone at the ledge.
- Refer to prior sections on recommendations for rubble granite foundation walls.
- Repaint the basement areaway door.

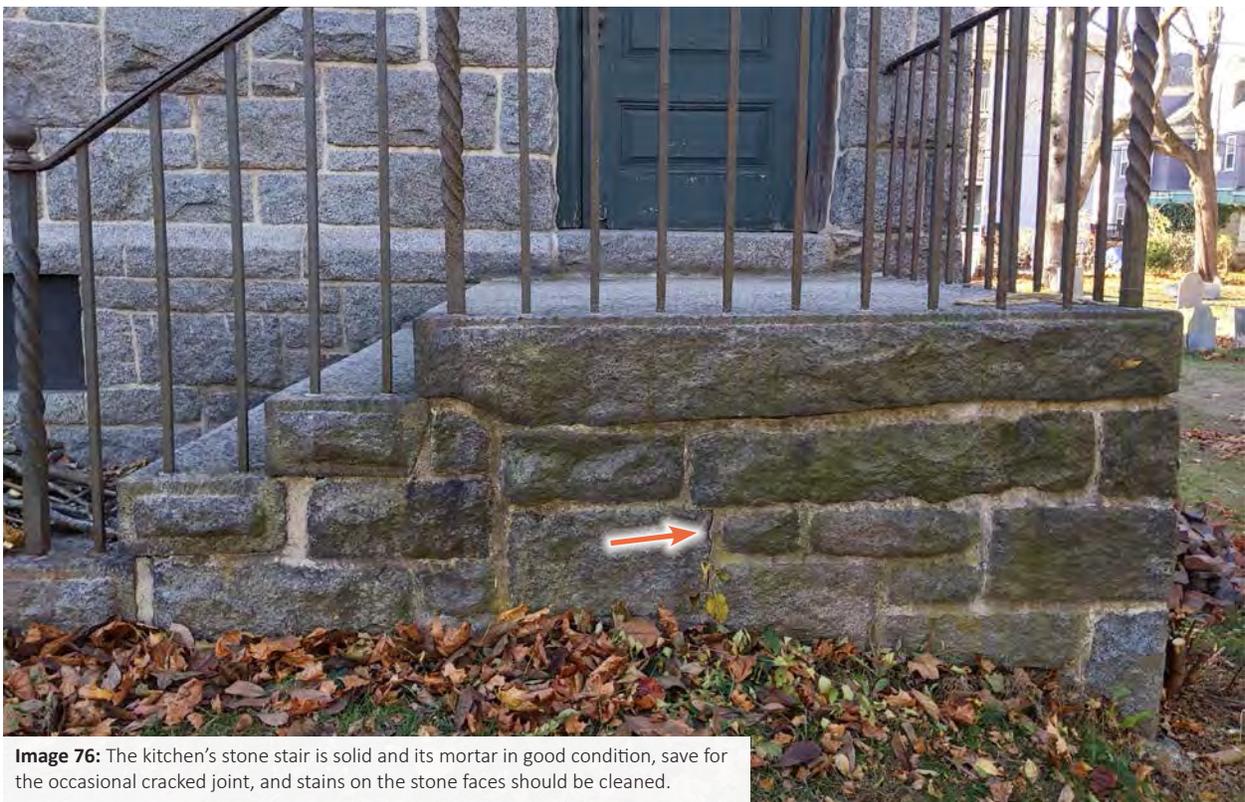
Image 76: The kitchen's stone stair is solid and its mortar in good condition, save for the occasional cracked joint, and stains on the stone faces should be cleaned.

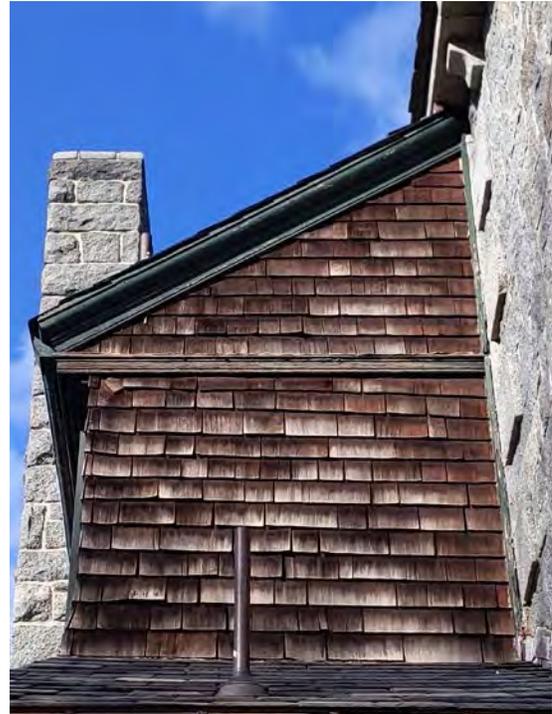
At the gable and cheek walls, the parish hall is clad with wood cedar shingles, coated with a stain. One exception is the second story of the 'chancel block' by the southwest parish hall entrance. Here, the shingles have begun to curl and cup, and a few are missing or dislodged [Image 77]. The siding on both wall planes should be replaced. At the gable and cheek walls, the siding is generally in better condition. Shingles that have been protected by the overhanging gable arch appear tight and solid, although there is a haze of organic growth. However the shingles on the face of the gable arch are both worn and discolored, with obvious signs of curling and cupping [Image 78] (a sign of water absorption due to lack of maintenance/staining). These shingles should be replaced. A faded louver sits at the top of the three gables, serving an unknown function as they are not seen in photographs from 1920. At the very least, these louvers should be painted to match the shingle siding. On the west gable wall, a piece of timber appears attached to one of the cheek walls, which may have been installed ad hoc to support a sign or other temporary feature [Image 79]. Given its lack of function, the timber and any fasteners should be removed.

Image 77: Curled and cupped shingles at the chancel block should be replaced.

- Replace deteriorated wood shingles, and re-stain all to match.
- Clean any organic growth from wood shingles.
- Paint gable louvers to match shingle siding.
- Remove defunct timber from west gable cheek wall.
- Conduct paint analysis to determine historic colors of woodwork.
- Prep and paint all wood trim throughout parish hall.
- Repair (epoxy consolidation or patching) or replace deteriorated wood trim throughout parish hall.

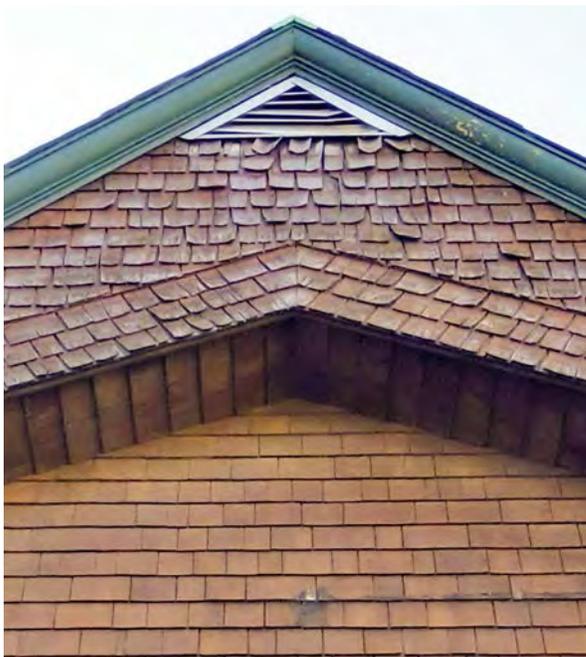
Image 78: Shingles on the overhanging gables arches show considerable deterioration. The gable louvers could blend in better.

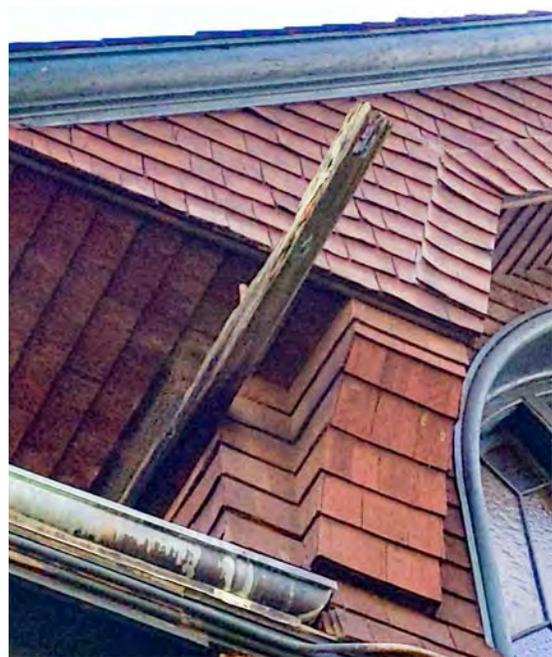
Image 79: A mysterious timber, installed ad hoc for an unknown purpose, has is aesthetically distracting.

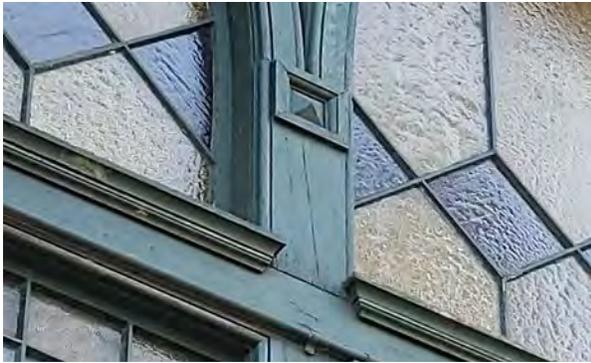
Image 81: Other examples of more detailed trim in good condition..

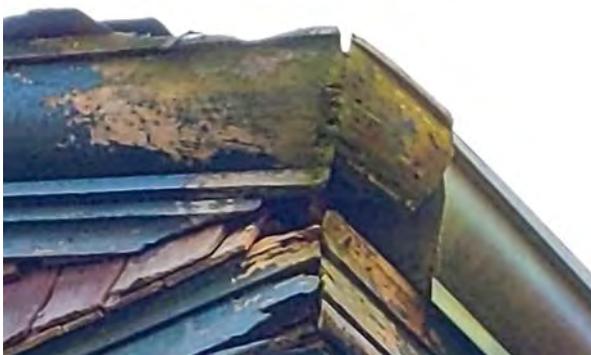
Image 83: Some of the eave mouldings are heavily deteriorated and required repair (consolidation) and replacement in-kind.

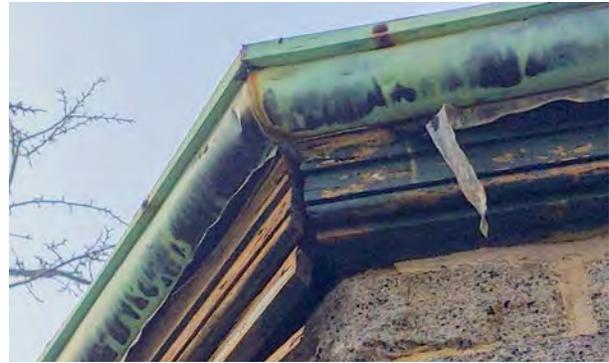
Image 82: Deteriorated fascia boards are likely in disrepair due to years of failed gutter flashing, and require tandem replacement.

Elsewhere, there are signs of moderate and advanced deterioration of woodwork and trim. The condition of the fascia boards — which support the gutters as backboards — varies quite a bit, with some that have started to complete split **[Image 82]**. Some corners, where gutter profiles at the eave transition into the raking cornices of the gable walls, are very deteriorated **[Image 83]**, with openings that need to be sealed. The worst offender is a damaged wood assembly at the cheek wall of the north dormer above the Eliot street entry **[Image 84]**. Here, the woodwork and dormer sheathing along the eave appears to have suffered the effects of moisture by collecting snowbanks in the valley and lack of maintenance. Damaged portions should be repaired or replaced. Snow load removal is difficult to mitigate due to the existing configuration of the roof. Annual inspection and maintenance is the most prudent course of action for its longevity.

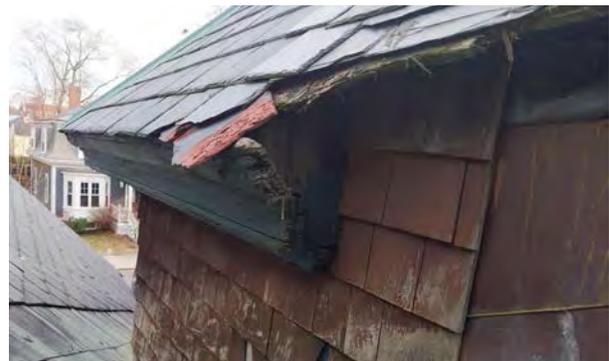
Image 84: Hiding around the cheek wall of the north dormer, moisture and snow have wreaked havoc on this wood assembly.

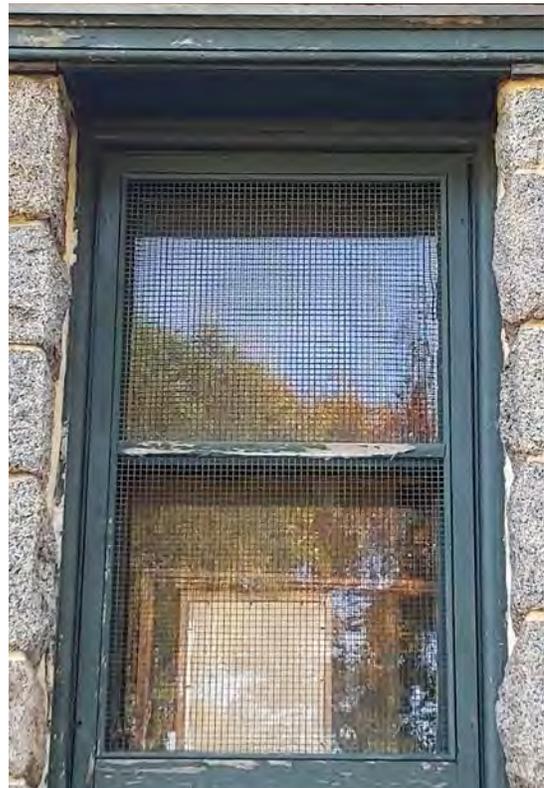
Image 91: Overall, double-hung wood windows are in acceptable condition in terms of woodwork and require preparation, priming, and painting..

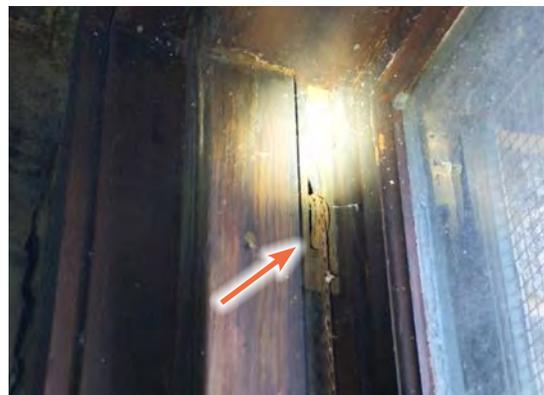
Image 92: Existing wood windows are hung with chains, and should be inspected for operation.

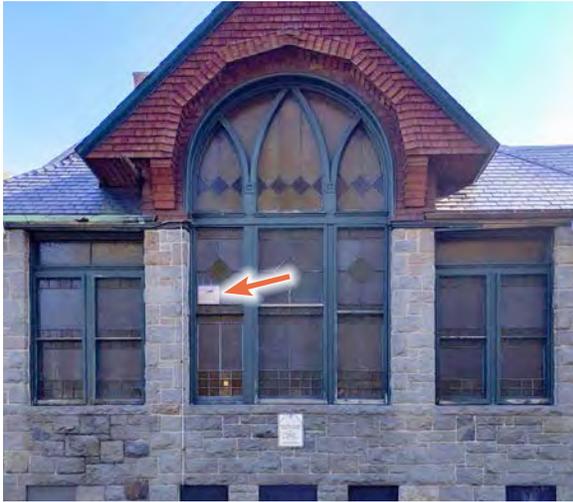
Image 93: Of the parish hall's highlights are the lancet windows in the west gable. The highlighted unit requires replacement of missing glass and painting..

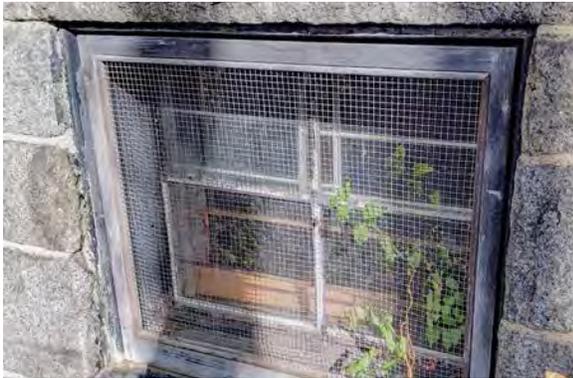
Image 94: The only exposed basement window at the south gable required restoration.

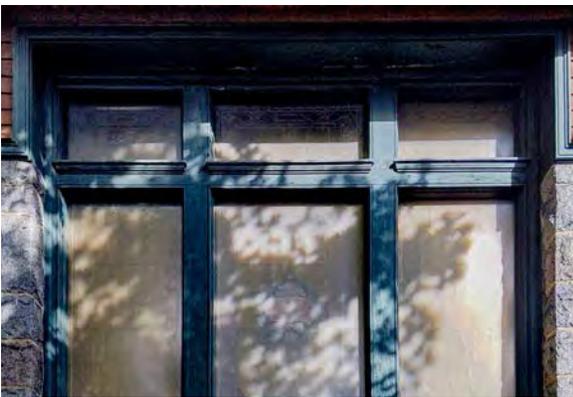
Image 95: The stained glass windows at the south gable require only some sill repairs. The acrylic panels need replacement.

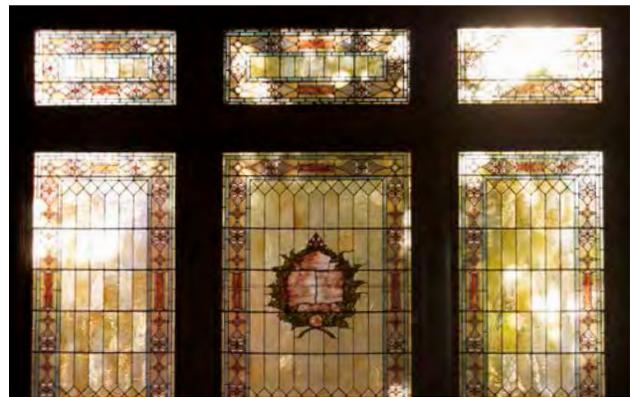
Image 96: The lead comes and glazing in the south gable window are in remarkable shape, and will only look better with safety glass covering.

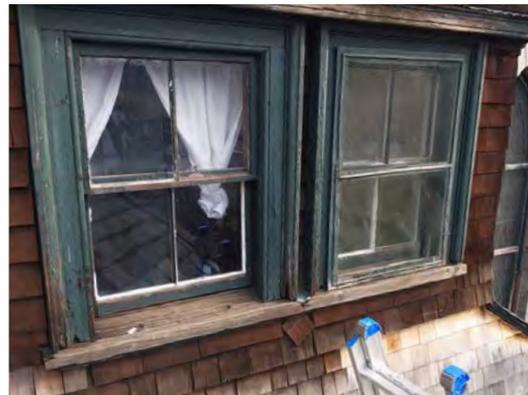
Image 97: The double-hung wood windows and trim in the chancel block are in desperate need of repairs.

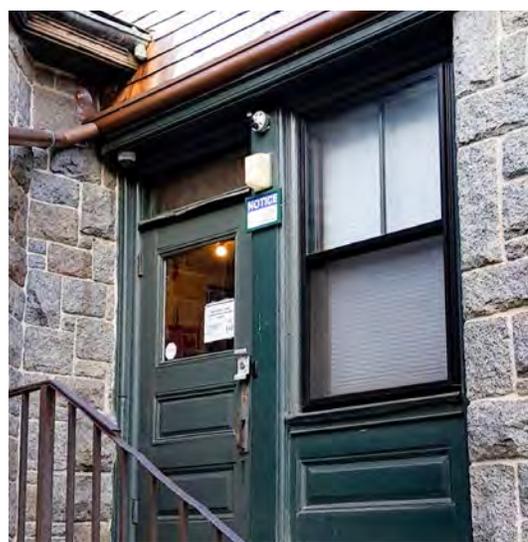
Image 99: The southwest parish hall entry woodwork is in good shape, but need long-term rainwater protection.

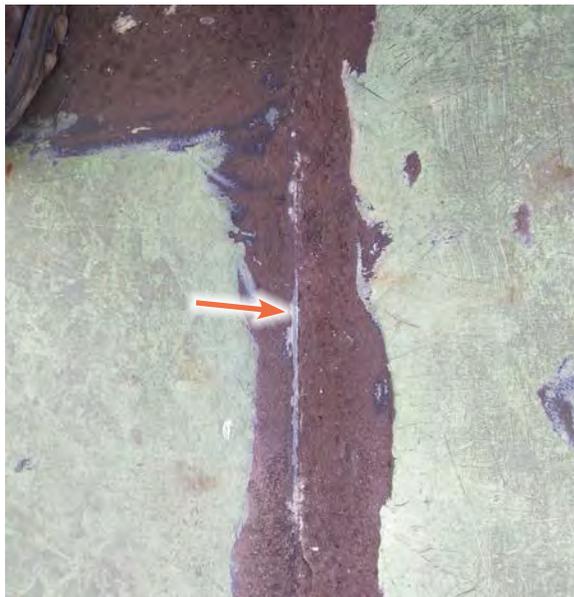
Image 101: 'Quick fix' tar repairs at copper panel joints eventually give way.

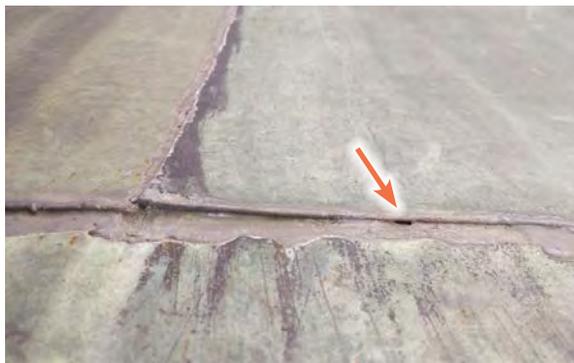
Image 102: Pin-holes at solder joints between copper panels are inconspicuous, but detrimental.

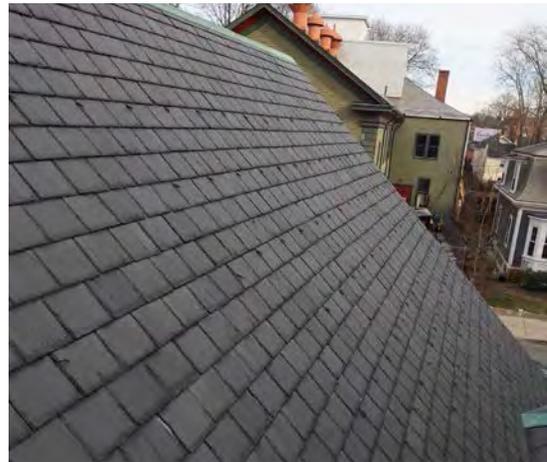
Image 105: The parish Hall's black Monson slate roof is immaculate, although not original. The slates ring like a bell.

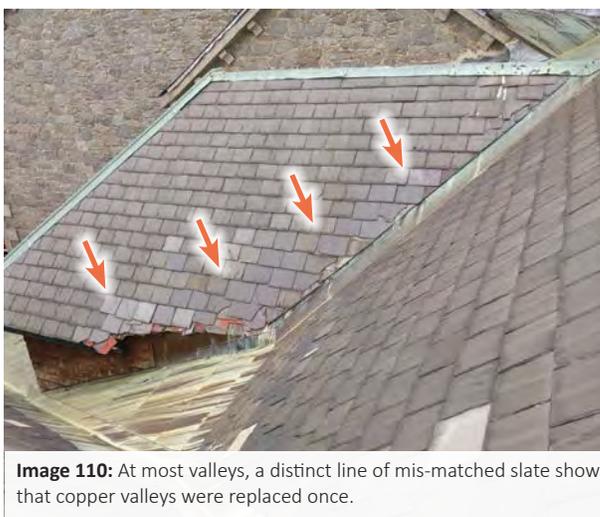
Image 110: At most valleys, a distinct line of mis-matched slate shows that copper valleys were replaced once.

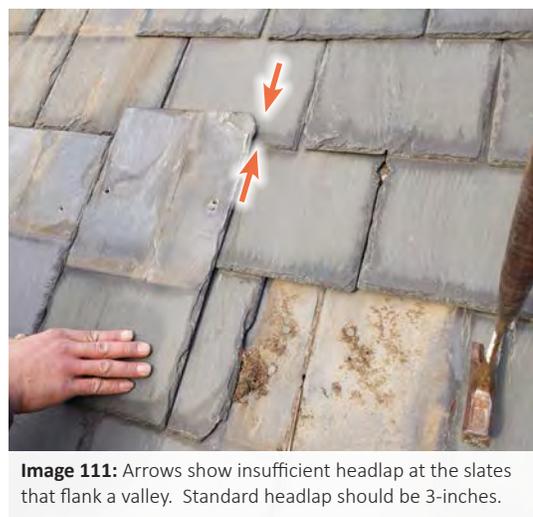
Image 111: Arrows show insufficient headlap at the slates that flank a valley. Standard headlap should be 3-inches.

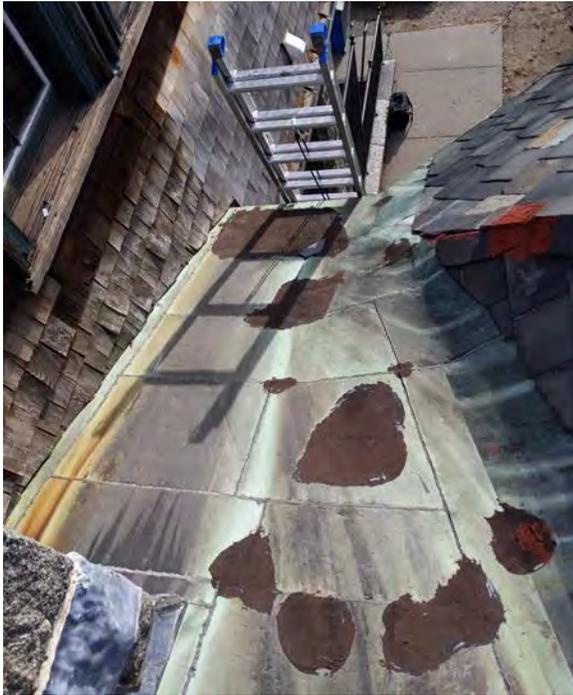
Image 112: The southwest entry roof was recipient to many applications of tar on seams and holes in the copper

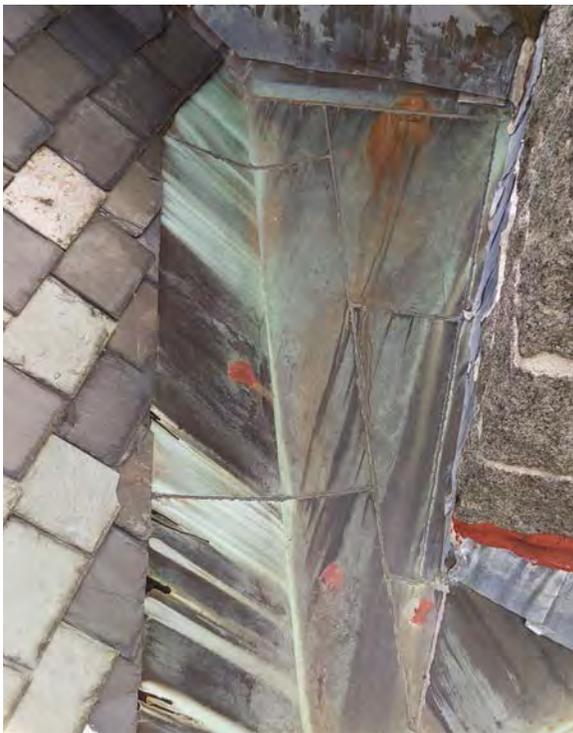
Image 113: The copper valley twists tightly around the chimney by the Morse room and southwest entry.

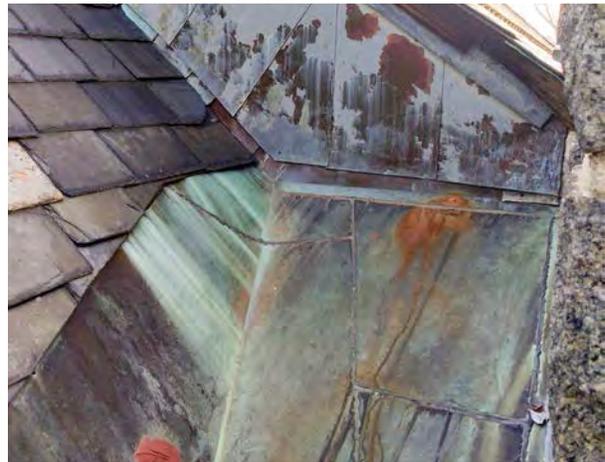
Image 114: Counterflashing at the chancel block roof is normally hidden from view, and should be replaced.

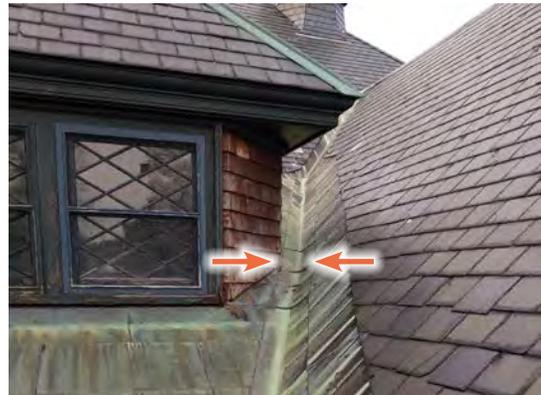
Image 116: A narrow valley creates a bottleneck for rainwater and snow to collect.

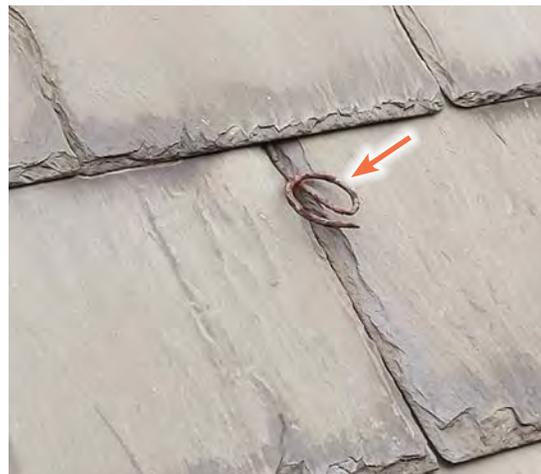
Image 117: Once-trendy and affectionately dubbed 'pigtail' snow pads fail and flatten after years of sliding snow.

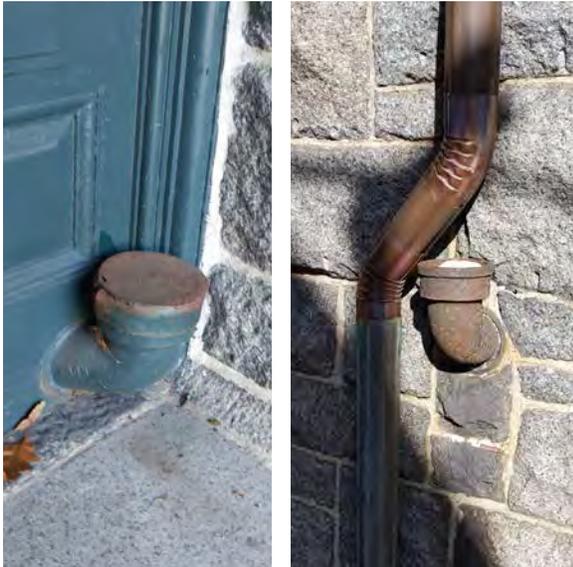
Image 121: Now-plugged internal downspouts boots dot the facade, seen today.

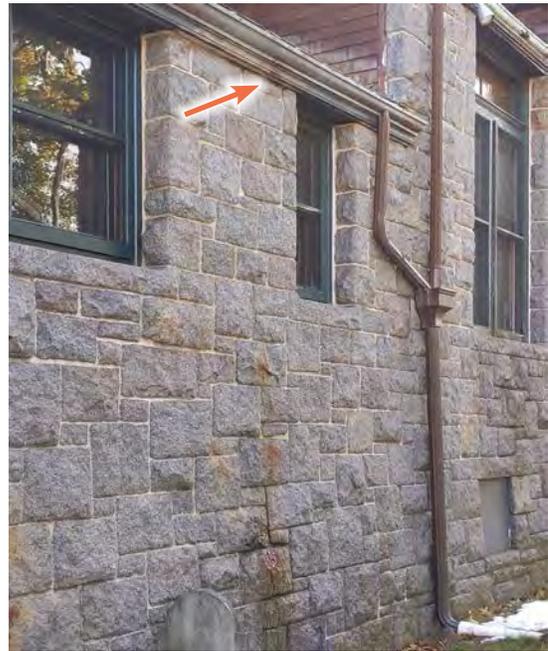
Image 125: Breaks in the parish hall gutters visibly leak water onto the stone below, staining it.
