PART TWO: OBSERVATIONS & TREATMENT RECOMMENDATIONS

EXTERIOR CONDITIONS CHURCH

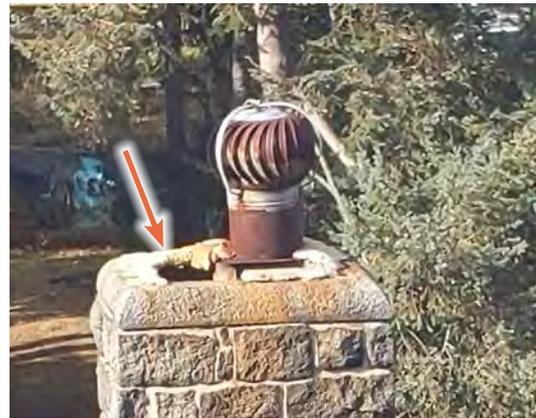
Image 132: A rusting turbine and missing parge cope/ chimney cap at the kitchen chimney.

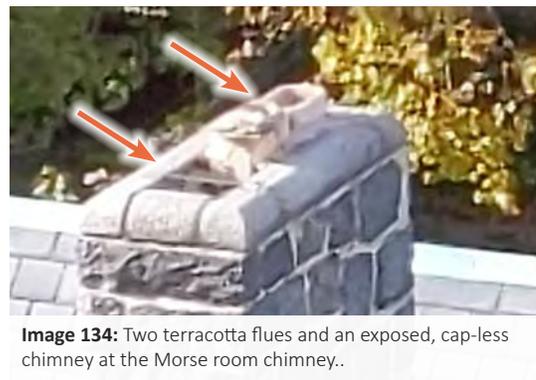
Image 134: Two terracotta flues and an exposed, cap-less chimney at the Morse room chimney..
