PART TWO: OBSERVATIONS & TREATMENT RECOMMENDATIONS

EXTERIOR CONDITIONS CHURCH

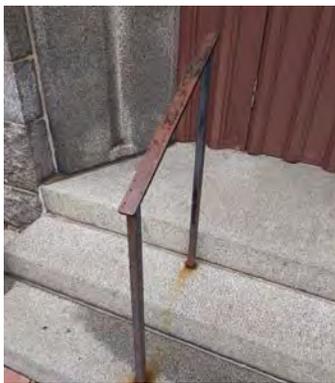
Image 02: Left: The remaining iron rail. Right: former anchors for the sister rail.

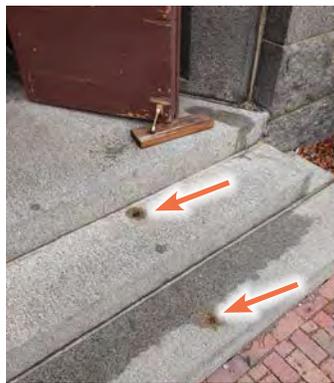
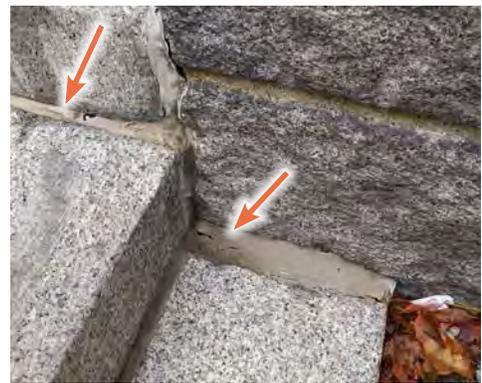
The tower's exterior walls are built of quarry-faced ashlar granite with dressed quoins at the corners and openings. There, the stones and their joints are in good condition thanks in part to an extensive repointing project done in 2012, where all elevations were treated. A thorough review of the stonework elsewhere is included in later sections. The tower serves as the ceremonial entrance to the church. The front door is recessed in a pointed arch lined with dressed granite voussoirs. The door and its surround is constructed with a board-and-batten wood design, and is in good condition [Image 01]. One iron rail remains embedded in the monolithic granite steps, its sister rail since removed [Image 02]. The granite steps are stable and level, and their joint sealants exhibit mostly cohesive failure, requiring replacement [Image 03].

Image 03: Cohesive and adhesive failure at the joint sealant between the granite steps and exterior wall.

- Replace deteriorated sealant at the monolithic granite entry steps.
- Clean and grout the voids below the granite threshold. Provide a solid footing beneath the granite landing.

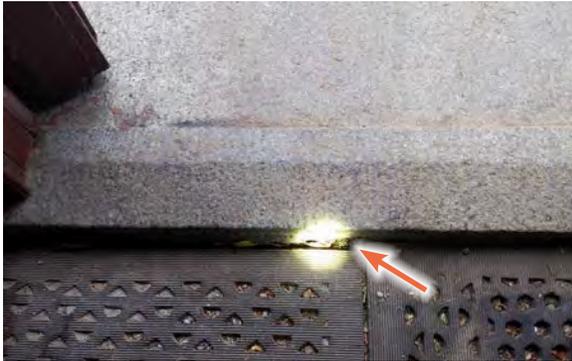
Image 04: Gaps in the entry granite threshold, adjacent to the recessed floor for walk-off mats to lay in.

On the other side of the doorway, a recessed floor allows thick walk-off mats to lay flush with the interior cork floor. Here, a cavity under the granite threshold is seen [Image 04]. Elsewhere at the threshold, stone is chipped and a cavity collects leaves and debris [Image 05]. There appears to be a large void under the granite landing as seen from the crawl space below the tower [Image 06]. The interior of the tower at the first level serves as a vestibule. Steps lead to the sanctuary, a spiral staircase to the organ level, and a floor hatch to the crawl space below.

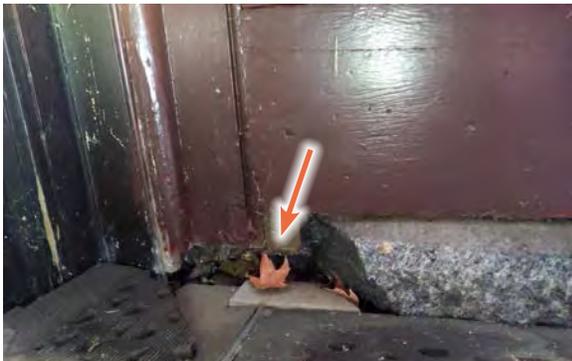
Image 05: Larger voids in the granite threshold offer a place for leaves and debris to collect.

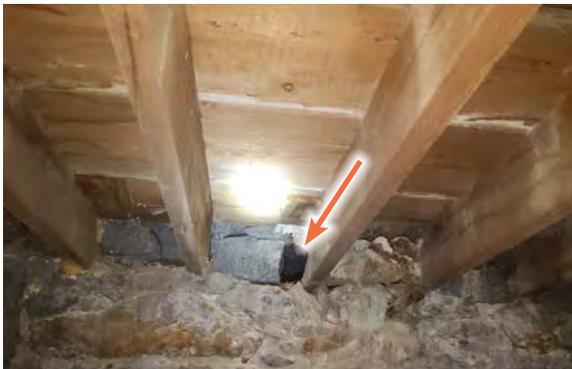
Image 06: The crawl space offers views to the underside of the granite threshold and landing, which show little support beneath.

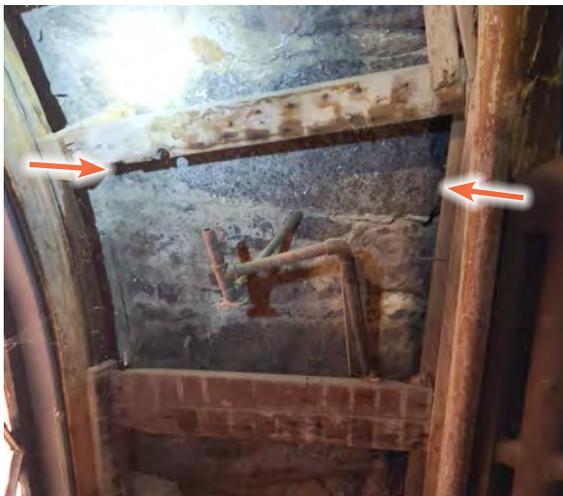
The organ level is partially finished at the interior, but a narrow corridor along the north side provides access to the top of the first-floor lancet window. The window is set in the masonry opening, where the wall construction is visible and stone ties were employed between the inner and outer walls [Image 08]. A narrow staircase up the east wall provides access to the tower proper [Image 09], with a chance to inspect the masonry, which is in good shape although some mortar is dusty. Here, a large lancet window is similarly constructed to the narrow windows that flank the tower and exhibits some exterior paint wear [Image 10]; it was restored in the early 2000s. Unlike the narrow windows which are fixed, these sashes are hung with chains and weights [Image 11]; however, the sashes do not appear operable, with little need to. The granite sill at the exterior exhibits three cracks, which should be repaired. Painting of windows is long overdue given the average life of paint at 7-10 years.

Image 08: The exposed lancet window at the organ level offers a chance to see part of the wall's construction.

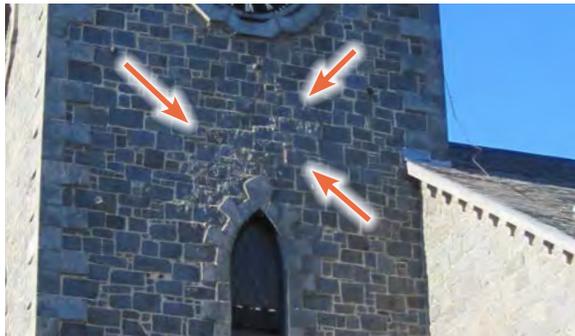
Image 13: This photo from 2010 was carefully-timed to catch light gleaming off the protruding 'bulge'.

Most importantly on the Eliot Street (northeast, called north) facade, the upper dressed voussoirs and keystone — as well as the surrounding ashlar granite — exhibit a clear 'bulge' outward, visible from the ground by eyesight alone [Image 12]. This 'bulge' has been remarked upon in a series of previous reports and observations although the extent of progression is unknown [Image 13].

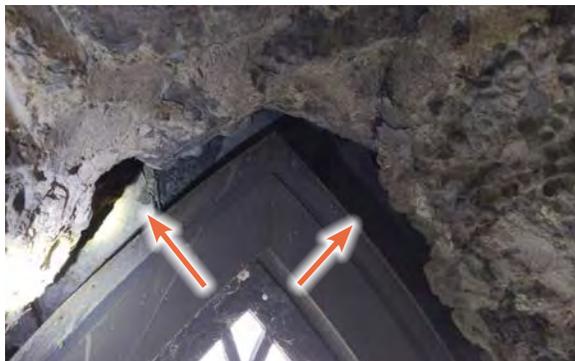
Image 14: Voids on either side of the north window reveal where the granite had de-bonded from its puddingstone backup.

By 1990, it was sufficiently troubled to warrant stabilization. A large, cavernous void investigated at the interior of the window has shown that the exterior ashlar granite wall has de-bonded entirely from the Roxbury puddingstone backup [Image 14]. Any mortar that once joined these two walls has been eroded, likely by water infiltration over the life of the church. In traditional mass-masonry wall construction, both the window trim stones and wall stones should be deeper and interlocked into the backup masonry to 'tie' the inner and outer walls together [Image 15]. Here, there appear no such 'tie' stones. This could be a localized issue, however the anchors seen around the clock (discussed in the next paragraph) suggest that this issue may exist elsewhere, at least at the level above. It's unknown if other tower walls were constructed similarly, a fact which should be investigated carefully. It is SSV's opinion that this 'bulge' should be temporarily braced with timber for safety until the latent issues are addressed. For an in-depth analysis of the masonry at the tower and recommended treatment, refer to the *Structural and Masonry Reports*.

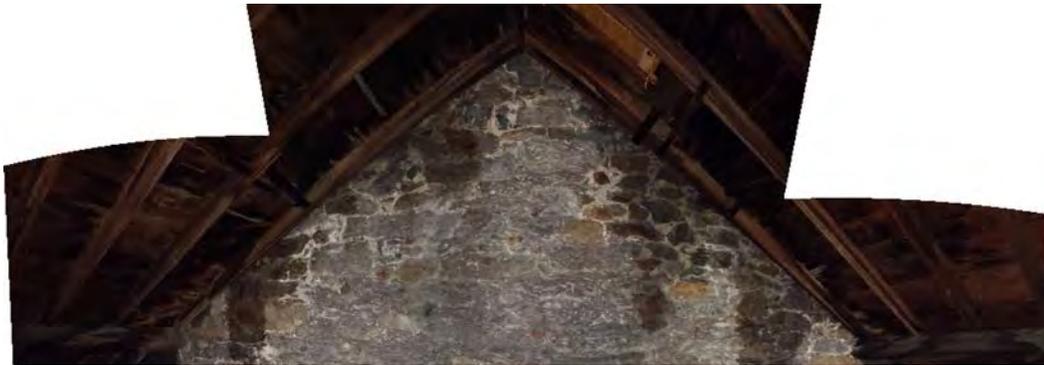
This 'attic level' provides the means accessing the sanctuary's 'attic' truss space. From this attic area, the rear (northwest, called west) side of the tower is visible from within the building. On three occasions this wall was observed on both dry and rainy days [Images 16-18]. Signs of water from the roof intersection above were present, and walls were damp to the touch. Although the masonry walls of the tower are in question, it is likely the deteriorated slate roof is the culprit. Conditions of the roof are discussed in a later section. A clever system of ventilation from the sanctuary was once routed through the long attic space and in through two oval, hinged panels that flank the tower [Image 19]. An abandoned wood-framed duct system is visible and vertically continuous from this level upwards to the belfry [Images 20-21].

Image 17: A rainy, November 23rd, 2020 day leads to water soaking the roof sheathing and dripping down the stone.

- Mitigate water infiltration at the roof-tower intersection by following the recommendations outlined in roof section, later in this report.
- Investigate the trim stones and their joints at the clock. Repoint and flash as required to mitigate water intrusion.

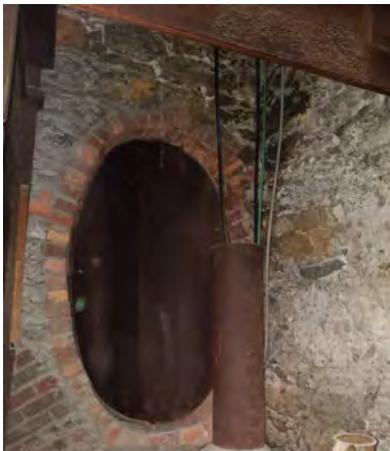
Image 19: An oval, hinged panel once vented into wooden duct shafts.

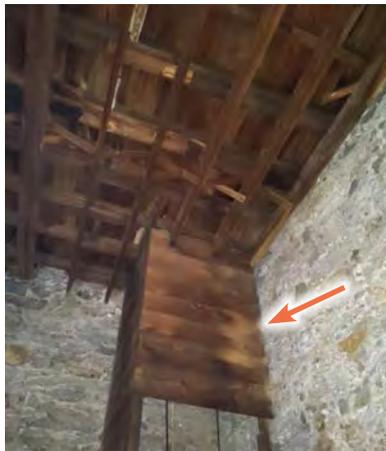
Image 20: The wooden duct shafts seen from the clock level, up thru the belfry.

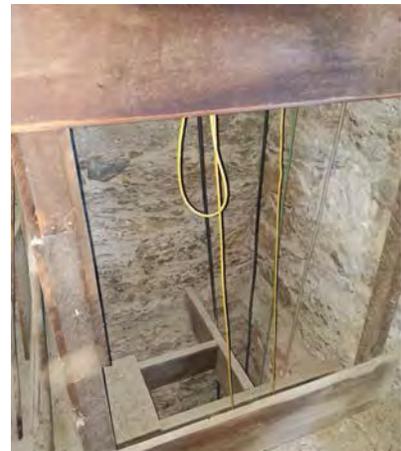
Image 21: The former wood duct shafts extend up through the belfry.

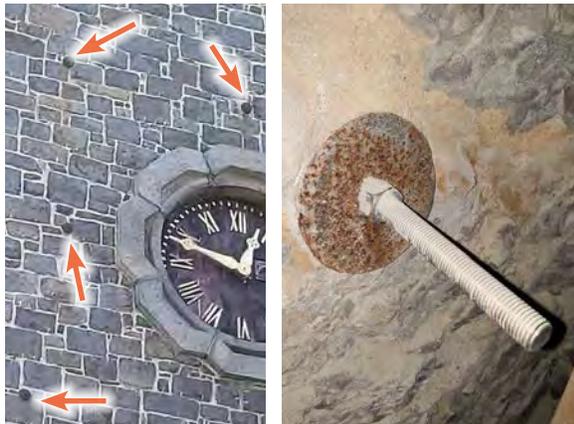
Image 22: 8 thru-wall ties surround the north clock. Threaded rods and washer plates are seen from within and without.

This level houses the tower's three operating clocks. The ashlar wall at northern clock is surrounded by eight thru-wall plates and ties, seen from within **[Image 22]**. As noted in the prior section of this report, this was installed to secure the de-bonded outer masonry wall from its puddingstone backup in the 1990 project. The circular clock openings penetrate the full thickness of the wall, with brick arches and a small access panel in the clockface **[Image 23]**. Each clock is powered by a restored Howard clock mechanism, counterweighted and hand-wound **[Image 24]**.

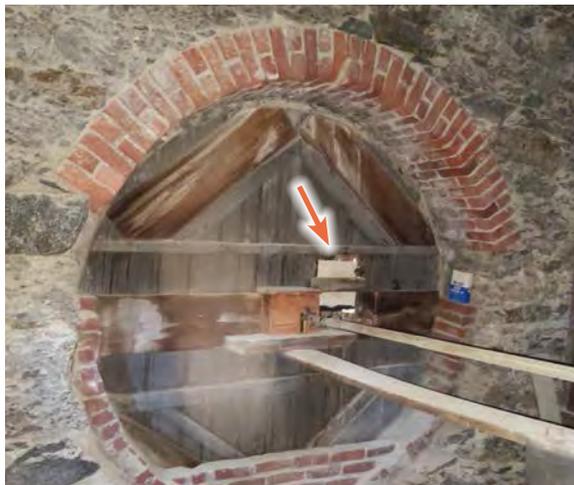
Image 23: Brick arches support the circular clock opening. An access panel in the clock face offers a view of the exterior trim.

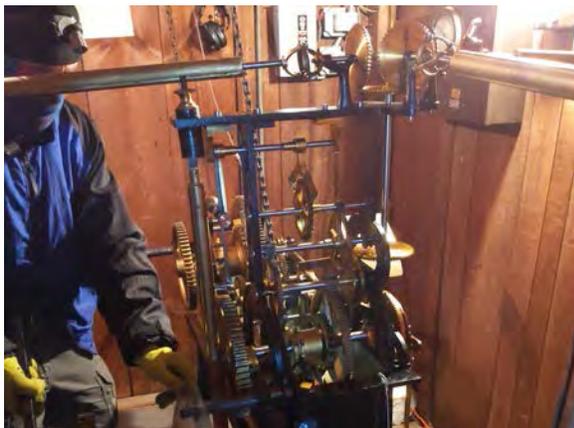
Image 24: The restored, hand-wound Howard clock runs like a top.

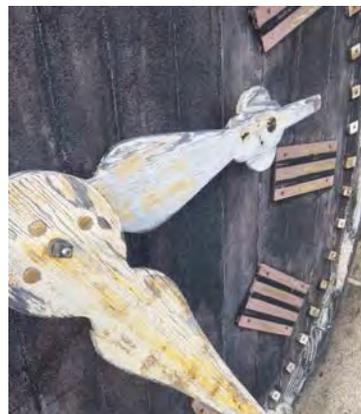
The clockface is made of wood, with a 'smalted' finish. An early-2000s project added a coat of black paint over the finish to prolong its life a bit more. The finish is very deteriorated **[Image 28]** and should be restored. The finish of the wooden clock hands is worn down to bare wood **[Image 29]** and should be refinished, gilded with gold leaf. The numerals and minute markers are also made of wood where one would expect metal. They appear intact although the finish is worn, and should be regilded as well **[Image 30]**. It was observed during a site visit that the south clock and its trim stones appear to show a slight 'lean' forward, similar to the 'bulge' seen at the north window. It is difficult to say if this was a trick of the light (as quarry-faced stone does not have a flush matte surface), or if a similar issue has emerged as it did at the north clock (with the surrounding ties). The *Masonry Report* outlines recommended investigative measures.

Image 29: The gilded gold leaf clock hands are worn to bare wood.

- Restore the smalted finish of the clock and gild the hands, numerals, and minute markers in gold leaf.
- Monitor the fiberglass louvers and repaint as part of a cyclical maintenance plan.

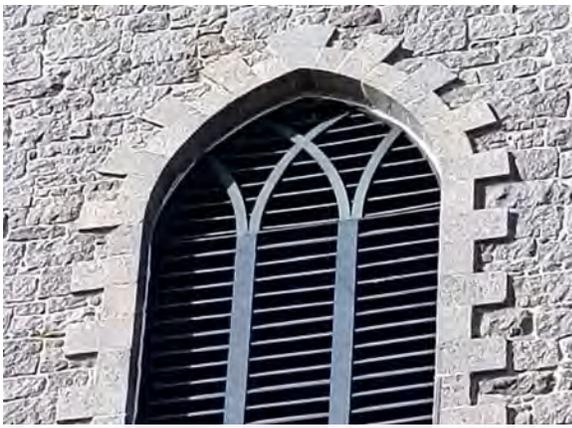
Image 32: Fiberglass louvers were installed with the cellular equipment to facilitate signal transmission.

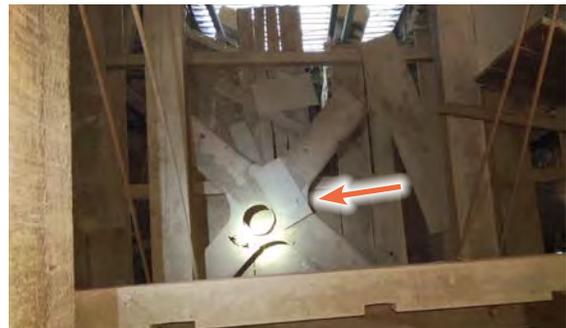
Image 38: An abandoned duct is tucked away above the bell. The four outlets may have exhausted out the roof dormers.

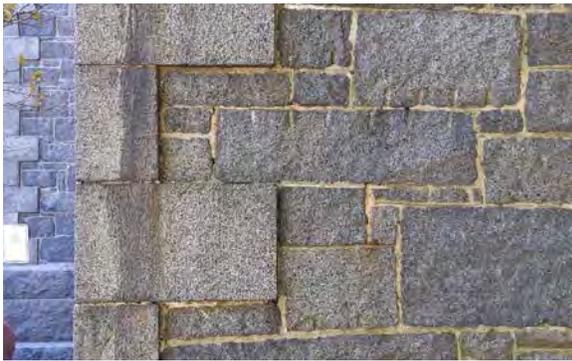
Image 40: The Eliot Street wall has borne its share of Nor'easters over the last 168 years.

The masonry walls along the Eliot Street facade (northeast/north) have not been repointed in quite some time, and have borne the brunt of the northeast driving drains over many years **[Image 40]**. One of the stone sills is cracked due to expected settlement of the stone below, and quick-fix repointing has been applied to the joints below **[Image 41]**. The crack in the sill should be properly repaired. The trim stones that surround each lancet window show deteriorated mortar, including the head joints between each projecting stone along the eave **[Image 42]**. A number of stone sills show green staining, likely from the painted mesh screens. Ultimately, this entire elevation should be repointed, one of the highest priorities due to its northeast exposure and prominence to Eliot Street.

- Repoint 100% of the masonry (foundations, watertables, ashlar granite, and trim) at the following elevations: north Eliot street façade, west gable wall including apse, and south wall.
- Clean all paint-stained granite sills.
- Repair the cracked granite sills.
- Investigate the voids found at the deteriorated west wall at the sanctuary and apse.
- Repoint the rubble granite foundation along the south façade.
- Clean the dark stains from the dressed quoins, at both corners of the southeast gable wall.

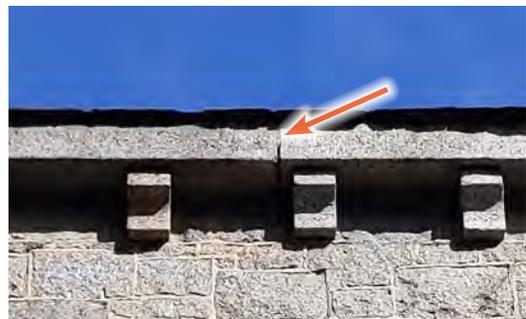
Image 48: Missing head joints at the stone eaves are at the mercy of overhanging slate above to divert water away.

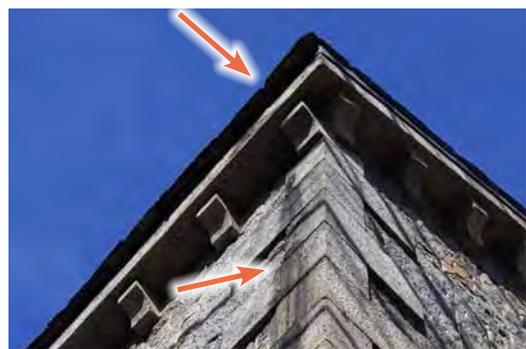
The southwest/south elevation of the sanctuary offers a chance to see the assembly of multiple stone types: the dressed window quoin trim stones; the quarry-faced ashlar granite walls; the quarry-faced ashlar granite watertable courses; and the undressed granite rubble foundation [Image 47]. The elevation is broad and not afforded the minor protection offered by neighboring houses and trees enjoyed by the northeast elevation. Although, its condition is not much different and requires repointing throughout, especially at the exposed rubble foundation. Stones at the eave show deteriorated joints [Image 48]. And the southern corner of the sanctuary shows dark stains from concentrated roof runoff, which should be cleaned [Image 49]. The eastern corner on the other side of the gable experiences the same staining.

Image 49: Dark stains from rainwater runoff seem to correlate with chips in the slate above.

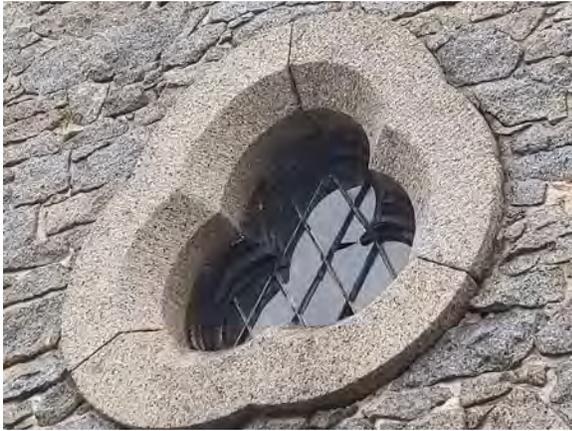
Image 53: A modest trefoil window hides high in the west gable for an aware looker to spot.

One trefoil window peers out from the top of the sanctuary's west gable wall, lined with dressed trim stones [Image 53]. Like the tower lancet windows, it is a wood sash with wood muntins arranged in a diamond pattern. The sash is fixed by a few thumb-turns on the inside, reached by traversing the attic space above the sanctuary [Image 54]. Glass lites are broken and missing, the sash and muntins are deteriorating [Image 55]. The window should be carefully restored, being one of the building's most charming features.

- Repair any broken wire mesh window covers and repaint to match windows.
- Restore deteriorated leaded glass windows, identified and elaborated on in the *Stained & Leaded Glass Windows Report*, and repaint sash frames.
- Restore the wood sash trefoil window high on the west gable wall.
- Monitor and repaint lower level window coverboards as needed to maintain.

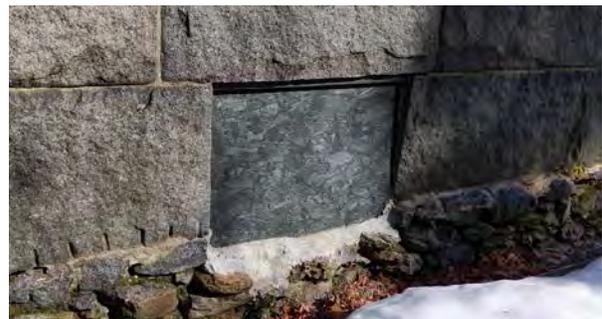
Of less importance are the boarded-up former windows in the basement level of the sanctuary. On either side, boarded windows in the granite watertable [Image 56] have been filled in with block, or left with sash intact. The coverboards should be monitored and repainted regularly to prevent undue wear. Some have been covered out of necessity for the accessible ramp on the north facade. Seen from the parish hall's basement, short-lived windows that once served the sanctuary are filled in with brick.

Image 56: OSB (oriented strand board) coverboard should be monitored and regularly painted.

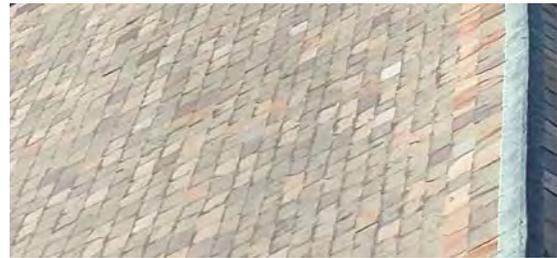
The sanctuary is roofed primarily in Vermont ‘Unfading Green’ slate [Image 57], which typically maintains its hue but develops a patina over time [Image 58]. Many mis-matched replacement slates show where repairs have been made over the roof’s long life. At the sanctuary and its small western apse, the slate has proved a reliable source of protection, but is tired and very leaky as seen from the attic interior. Sufficient headlap is seen after a slate is removed at the apse [Image 59], a sign of quality 19th-century construction. However small holes, loose nails, and an uncountable number of deteriorated efforts to replace individual slates are all means for water to infiltrate the roof [Image 60]. Some of the worst water damage stems from above the ceiling at a corner in the nave’s interior - discussed in a later section. Where the roof eaves rest on the exterior wall, a small gap between the bracketed stone band and roof sheathing lets a bit of light in to the attic [Image 61]. Installing a simple mesh screen at these gaps will deter the adept bat or bird from taking shelter. It poses little threat otherwise given the slate overhang. Settlement of the roof has caused slight bends to form along the slope, particularly where the horizontal purlins lie between the interior truss and rafters. These bends are subtle but may result in board sheathing that isn’t uniformly flat. The *Structural Report* outlines repairs needed at the truss, but the sheathing itself may need inspection after slates are removed.

Image 57: The church’s slate roof is speckled with replacement slates from over the years.

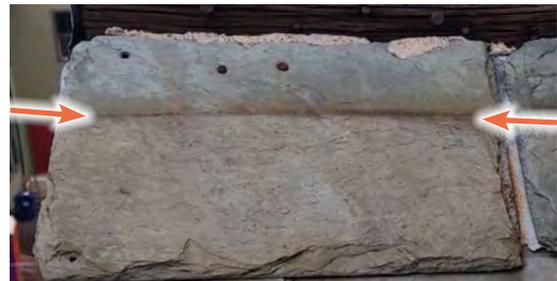
Image 58: A missing ridge cap offers a comparison between the slate’s original color, and weathered patina.

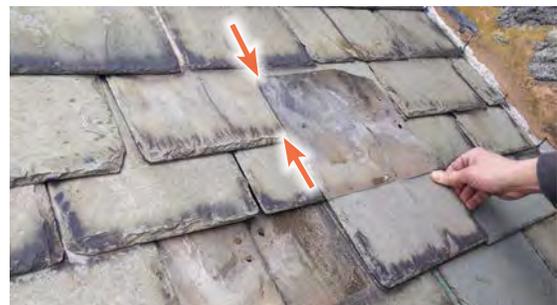
Image 59: An experienced slater deftly removes a slate to inspect. Arrows call out the generous headlap.

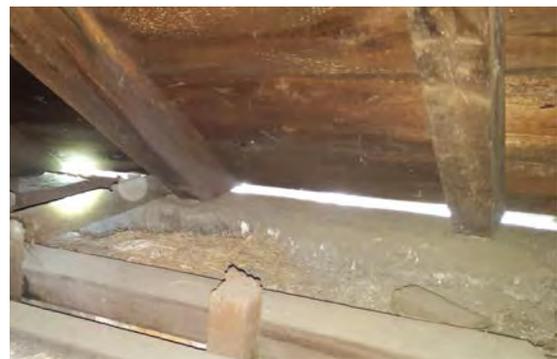
Image 61: Light shines into the attic where the roof meets the masonry wall. A mesh screen will deter any small intruders.

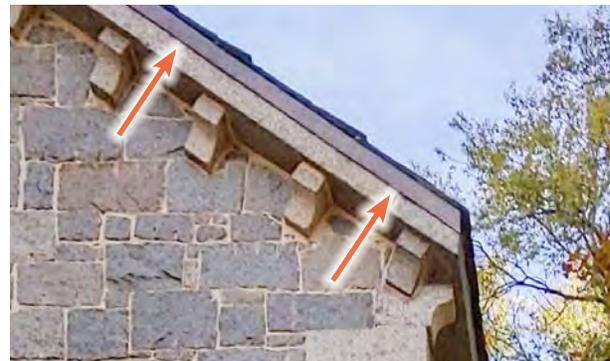
Image 64: Edge flashing at the raking cornice holds up well on both gable ends of the church.

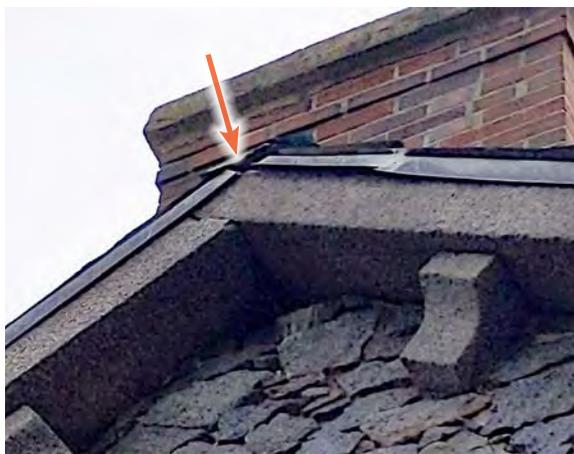
Image 65: Another questionable ridge cap, with a poor connection to the newer edge flashing that slopes either side.

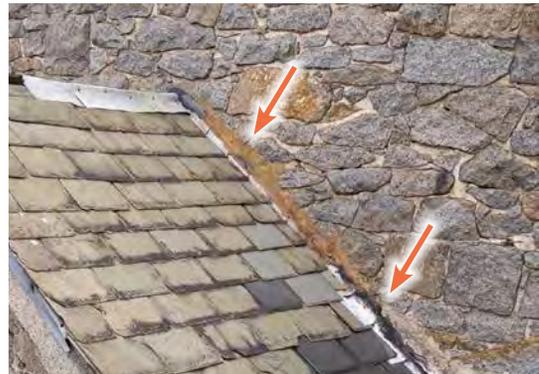
Malleable lead counterflashing where the apse roof meets the sanctuary gable wall has been obscured by mortar and sealant over the years, and would do well to extend higher up [Image 67]. Valley flashing for the parish hall roof is necessarily a part of the sanctuary's apse, and is discussed further in a later section. On the sanctuary roof, two copper-clad hatches (one high on the south side, one low on the north) are tired and should be replaced [Image 68]. The roof has served the sanctuary valiantly for many years, but is now one of the highest priorities for full replacement.

Image 67: Packed-on mortar and sealant over the lead counterflashing seems to suffice. Taller flashing is better.

- Repair the roof truss as outlined in the *Structural Report*. Investigate the flatness of the sheathing during roof replacement.
- At the nave: replace the slate roof entirely with Vermont 'Unfading Green' slate. The slate on the apse would be replaced at the same time, ideally.
- At the nave: replace ridge caps, and copper-clad roof hatches.
- At the apse: provide new ridge cap, edge flashing, step flashing, and higher lead counter flashing.
- Install mesh screen inside the attic at the gaps between rafters by the eaves.

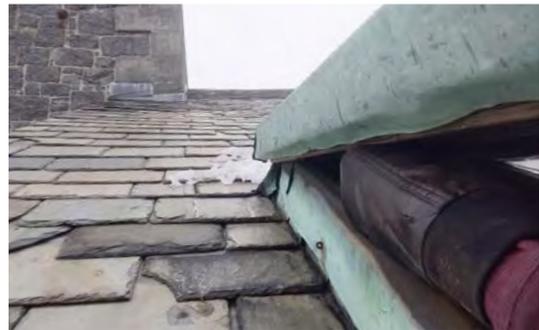
Image 68: A hair-raising scramble through the false clerestory window gives a chance to inspect the north hatch.

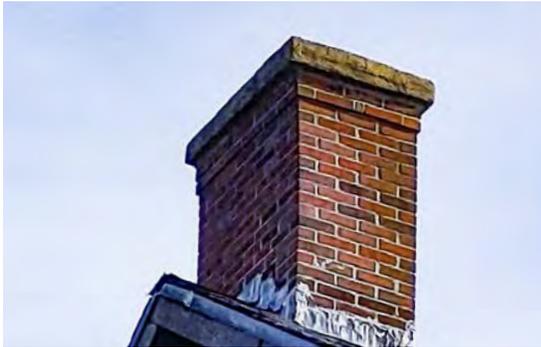
Image 69: The church's sole brick chimney atop the west gable wall. White lead flashing due to normal oxidation.

One rectangular red-brick chimney sits atop the west gable wall of the sanctuary, capped with a parged brick crown. Observations from the ground and tower suggest that the mortar joints exhibit some wear, but not excessive [Image 69]. The lead counterflashing has oxidized, turning shades of white but in good condition. The chimney should be re-flashed when the roof is replaced, and ideally repointed at the same time due to the economy of access. Barely seen from the belfry louver is an open flue in the stone crown [Image 70]. The chimney is inactive but once served the basement coal-fired heating system, and the open flue should be capped. While the chimney is not visible inside the occupied spaces of the building, it is briefly visible within the attic, extending down from the ridge and splitting around the trefoil window and through the framing below [Image 71]. The interior face of the chimney exhibits old mortar joints and a deteriorated parge coat over sections of brick; each should be monitored over time.

- Replace base and cap flashings during roof replacement.
- Repoint the entire chimney.
- Cap-off the open inactive flue.

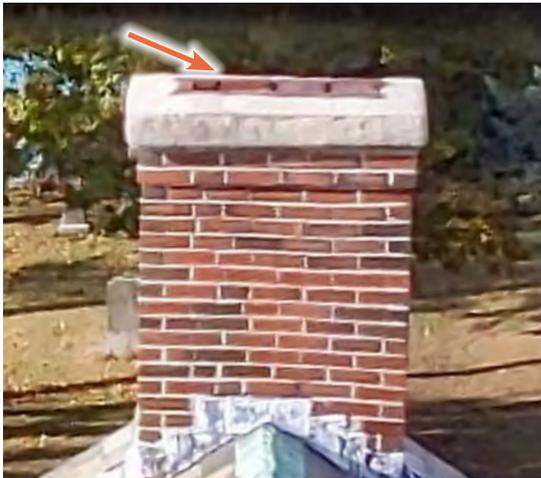
Image 70: The chimney has an open, inactive flue in the stone crown. Some water could enter during heavy rains.

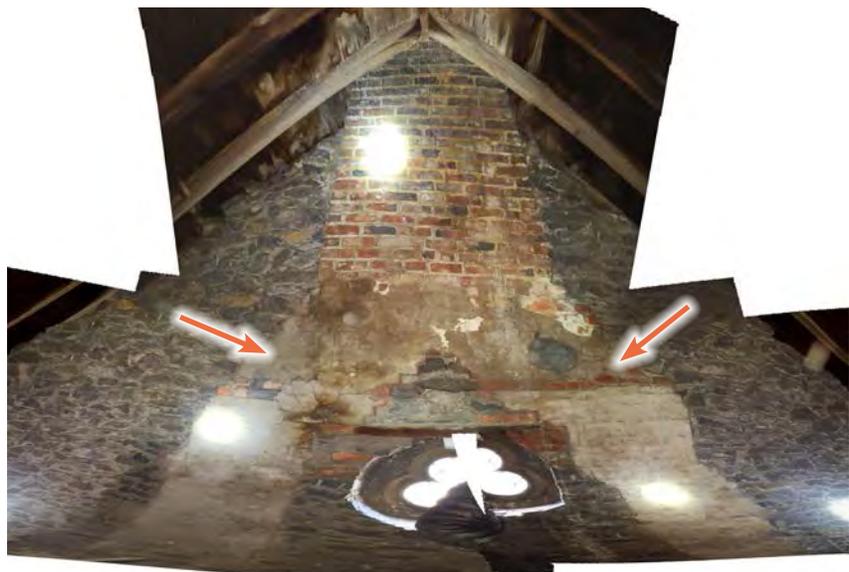
Image 71: The composite image, seen right, shows the interior face of the brick chimney and its parge coat as it splits at the trefoil window.

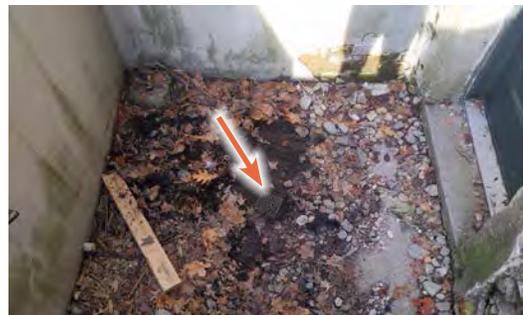
Image 73: The debris-filled landing impedes drainage and inspection of the drain over time.

- Clean the bottom landing of all dirt and debris. Inspect and dislodge blocks in the floor drain.
- Clean stains and organic growth from walls.
- Repair the deteriorated parge coat on brick wall and damaged/missing stone at the ledge.
- Refer to prior sections on recommendations for rubble granite foundation walls.
- Repaint the basement areaway door.

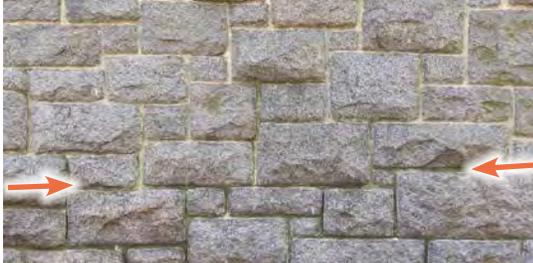
Image 74: The quarry-faced ashlar granite stone joints are in good condition, but exhibit some staining at grade.

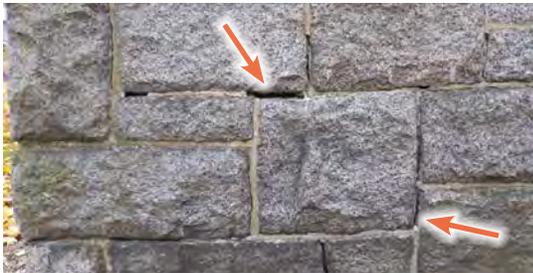
Image 75: Although most of the granite was repointed in the early 2000s, select areas of mortar show advanced wear.

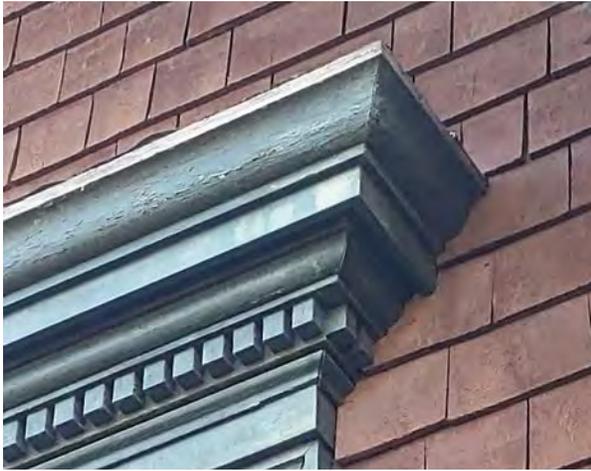
Image 80: Well-kept detailed trim can give thanks to the protecting overhang above and continued maintenance.

Like the siding, the wood trim throughout the parish hall is in good condition overall. Areas that are deteriorated, typically show as excessively worn and peeling paint. Some of the best-preserved woodwork is found at the cornice of the colored-glass windows in the north gable wall **[Image 80]**, thanks in part to the protection of the overhanging arch above, and proper maintenance of the paint, albeit slightly faded. Likewise, the woodwork at the tall colored-glass lancet windows in the west gable are in good condition as well **[Image 81]**. There are some signs of faded and chipped paint, and all of the woodwork here and throughout should be repainted to continue protecting the trim. It is unclear if the dark-green color is an original color or close to it, and a paint analysis should be conducted to determine to try determining the original.

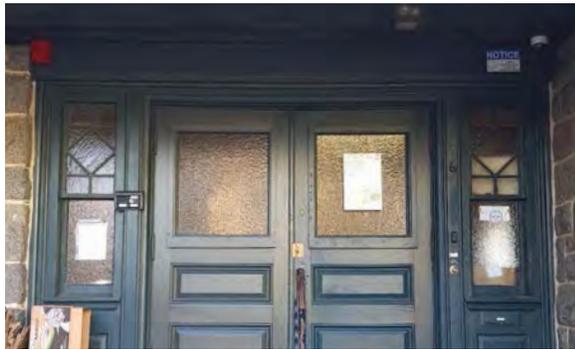
Image 85: The Eliot street entry has been protected by the deep overhang and good maintenance over the last few decades.

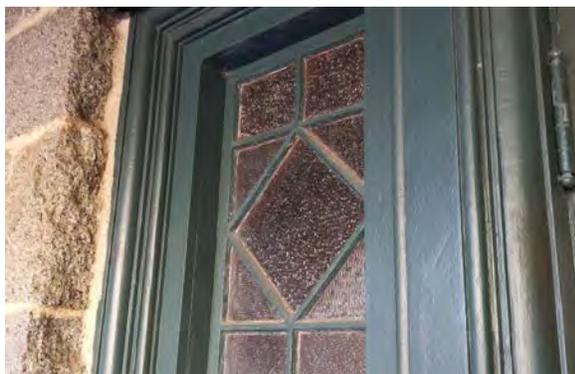
Image 86: Muntins in the sidelights of the Eliot street entry are tight and look great.

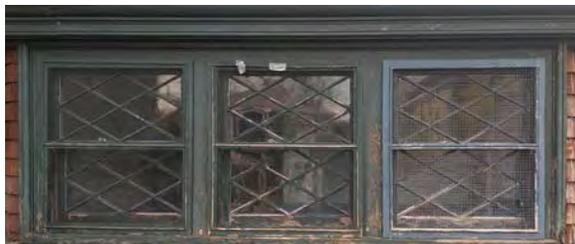
Image 87: The diamond-patterned windows at the north dormer are in need of restoration.

- Restore all deteriorated wood sashes.
- Repair all window trim in tandem with overall parish hall wood repair.
- Prep and paint all sashes and window trim in accordance with paint analysis conducted for overall woodwork. Replace caulking at brickmoulds.
- Consider removal of wire mesh panels at all windows. Otherwise, make repairs and re-paint.
- Remove entirely or replace translucent panels at stained-glass windows with safety glass.
- Follow recommendations in subsequent roofing/flashing section to mitigate rainwater issues at entry woodwork.

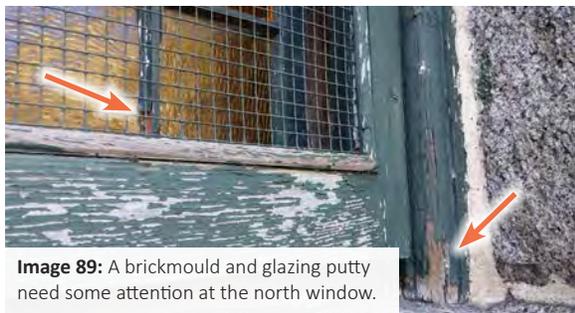
Image 89: A brickmould and glazing putty need some attention at the north window.

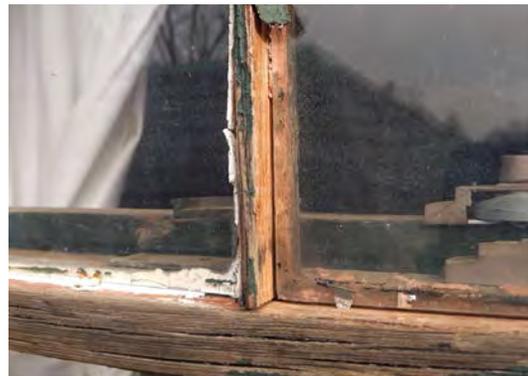
Image 98: Missing glazing putty and checked wood are primary concerns in the wood sashes.

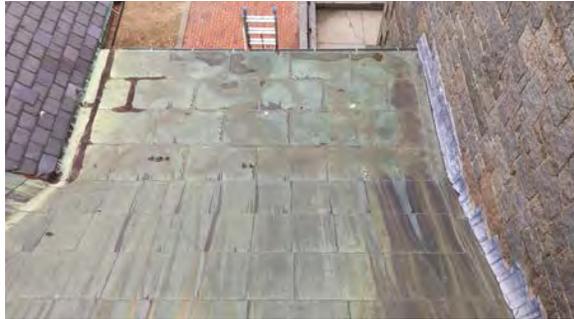
Image 100: The flat extension of the roof at the Eliot Street entry was not original, absent from 1920 photographs.

- Replace all flat-seam copper roofing at both Eliot street and southwest entries. Inspect wood framing at Eliot street entry — replace if rotted.
- Replace all copper flashings, including valleys, ridges, and eaves.
- Replace lead counterflashing at the sanctuary.
- Replace all copper gutters and downspouts.
- Provide additional downspouts at both Eliot street and southwest entries.
- Install snow pads at large slate roof fields that drain to the Eliot street and southwest entry roofs.
- Inspect subsurface dry-well at Eliot street entry for drainage adequacy.

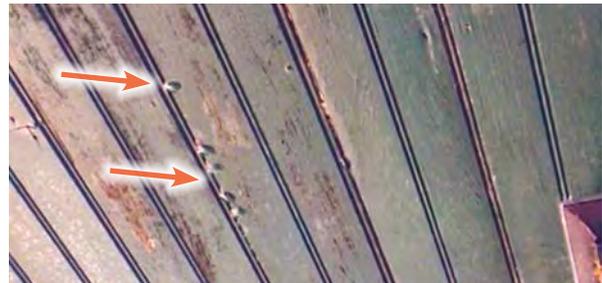
Image 103: Visible drips of water indicate that the flat copper roof above has started to fail. The concealed framing requires inspection.

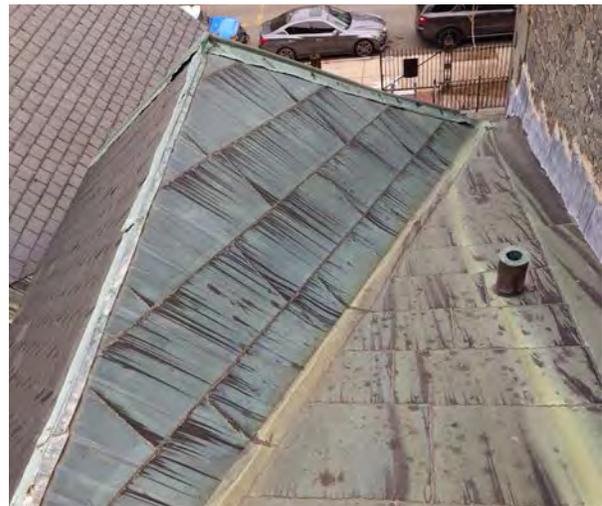
Image 104: Flat-seam copper roofing was also partially employed at the dormer roof above the Eliot street entry.

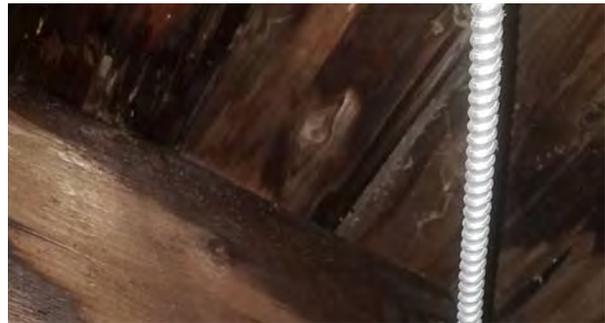
Image 115: Signs of water infiltration by the Morris room indicate that the copper roofing has started to fail.

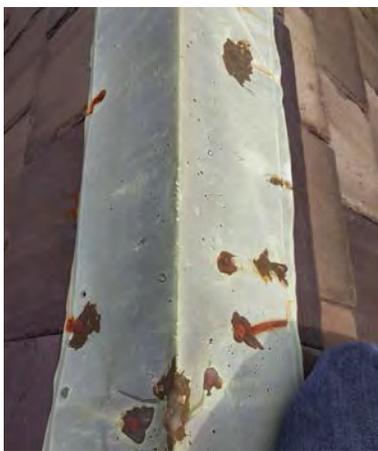
Image 118: Copper ridges are riddled with sealant and at the end of their life.

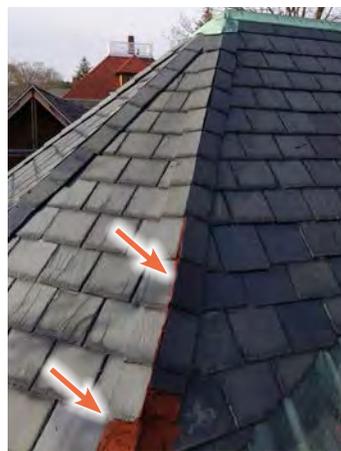
Image 119: Red roofing cement is often sloppily applied to slate hips.

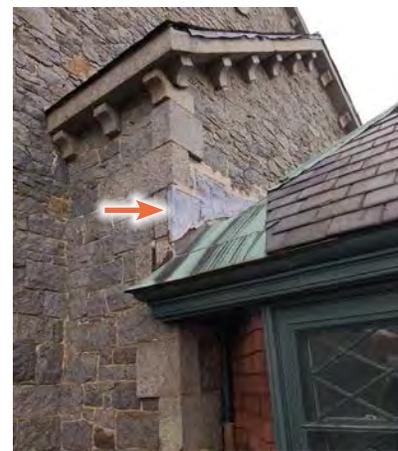
Image 120: Lead counterflashing should be replaced with the associated base flashing.

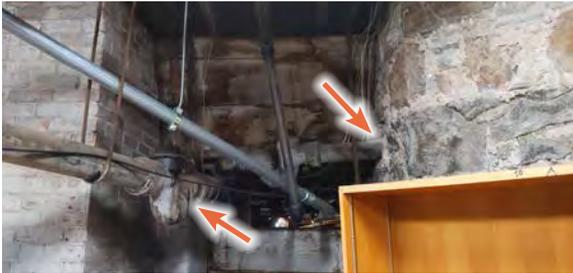
Image 122: Inside the parish hall, the former downspout boots once channeled water into the city's sanitary sewer.

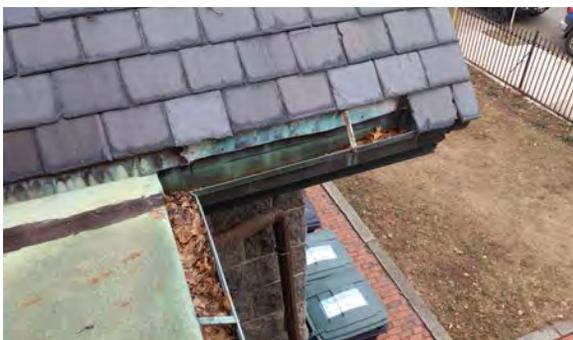
Image 124: The gutter above the Eliot Street entry and it's humble downspout currently serve nearly 2,300 SF of roof area.

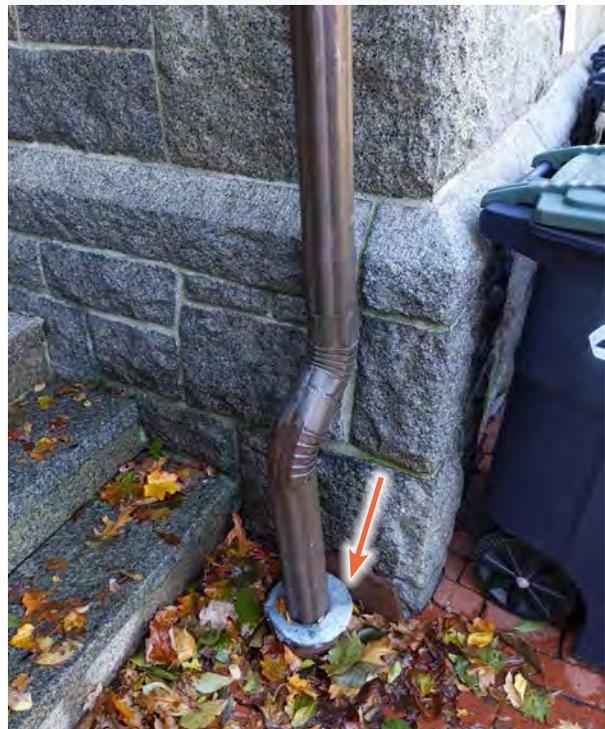
Tiered gutters at the high and low eaves on the parish Hall’s west elevation show signs of wear or poor installation. In one instance, a break of the seam between two lengths of gutters actively leaks onto the granite wall below, which is noticeably stained [Image 125]. Along the have of the Morse room hipped roof, the gutter was partially replaced with a questionable joint [Image 126]. The high downspouts at the chancel block by the southwest entry are so deteriorated that they no longer connect to their gutter above [Image 127]. In this area, the collection of gutters and a tight valley spell trouble for the entry below during heavy rains and snow when the gutters are overloaded [Image 128]. The sole downspout at the lowest section gutter serves nearly 1,500 square feet of roof surface above, and — like the Eliot street entry — is undersized. Another downspout added would aid the gutter greatly. Generally speaking, all gutters have reached the end of their service life, showing tar repairs and existing holes [Image 129] and require replacement.

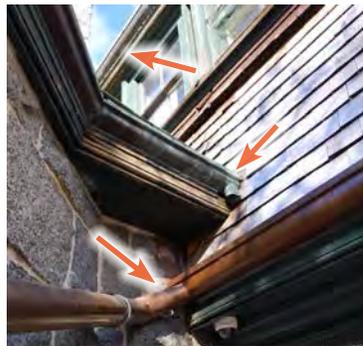
Image 128: Three gutter levels at the southwest entry are complex.

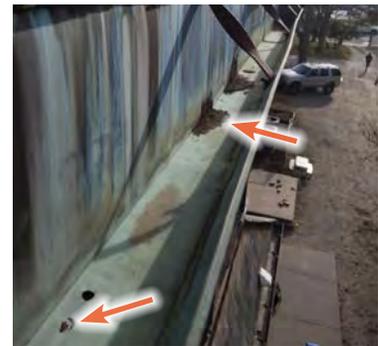
Image 129: Repairs and holes throughout the gutters warrant full replacement.

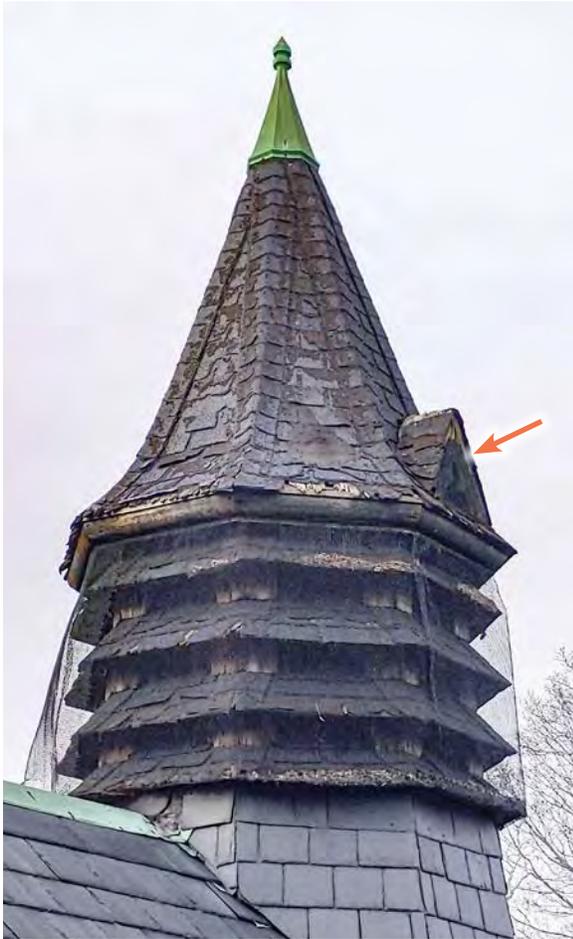
Image 130: The distinguishable ventilator has a number of features including three small, gabled 'blind dormers'.

Situated at the peak of the high ridge, towards the parish hall's east gable is a distinct octagonal ventilator [Image 130]. At one time, it served the interior hall's natural ventilation system, concealed in the ceiling. This ventilator is one of the parish hall's most distinctive marks, featuring a faceted, asphalt-shingled turret roof with three small blind gables, wood eave, four circumferential louver fins, and a sweeping faceted slate skirt that joins the slate hipped roof below. A black bird-deterrent netting covers the entire ventilator. Starting at the top: the existing copper finial appears to be in good condition from ground observations and could be re-used, but the deteriorating asphalt shingles should be replaced. The tight hips and facets lend themselves more easily to wood shingles -- as originally designed -- but could be clad in slate shingles by an experienced slater. Woodwork appears worn and partially deteriorated, and may need consolidation in addition to sanding and repainting. The integrity of the louvered fins should be closely inspected and repaired if deemed, with new copper flashing. The slate skirt [Image 131] could be re-flashed and slate re-used as part of this ventilator restoration, rather than the general roof-work. The bird netting provides a valuable service, but proves rather unsightly. At a minimum, discreet sections of netting/wire should be inset between the louvers rather than over the exterior.

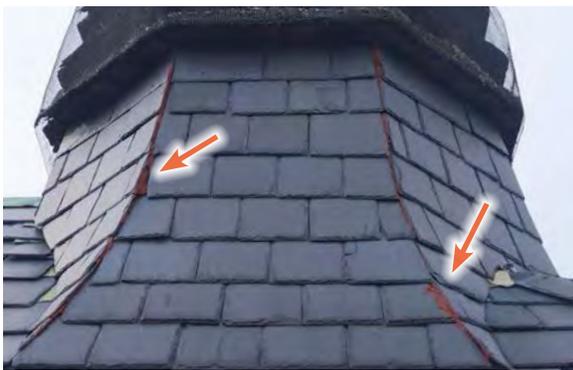
Image 131: Red roofing cement is packed at the mitered slate hips.

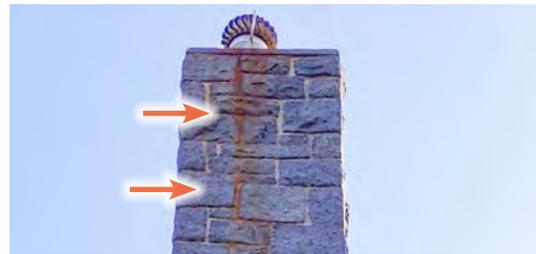
There are two chimneys that serve the parish hall. The first 'kitchen chimney' sits by the northwest corner of the parish house, constructed with the same ashlar granite as the rest of the building. At its top, a rusted turbine vent sits over a deteriorated parge coat, and is exposed [Image 132]. Rainwater has carried rust down both sides of the chimney, staining the granite, and should be cleaned [Image 133]. The rusted turbine should be replaced and a new copper chimney cap installed. The mortar joints are in good condition. At its base, a small copper cricket diverts water away from the chimney and is in good condition, but may be replaced during general roof re-flashing.

Image 133: Rainwater has allowed rust from the turbine to stain the ashlar granite at the kitchen chimney.

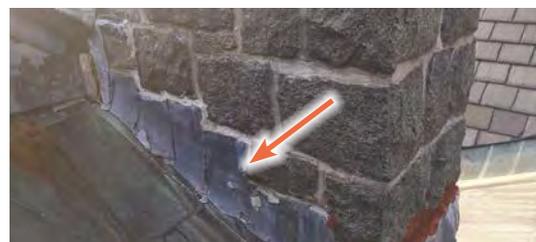
A similar, second ‘Morse room chimney’ by the parish hall’s southwest entry has mortar joints in equally good condition. The top of the chimney is missing a crown or cap, and along with two terracotta flues, is exposed [Image 134]. The base of the chimney sits in the complex arrangement of valleys described in the prior section. The lead counterflashing shows normal levels of wear, but should be replaced alongside the valley flashing [Image 135]. Due to the tendency of this area to collect snow and ice, it should be annually inspected. Aforementioned snow pads will help alleviate the amount of snow that this area experiences.

Image 135: Lead flashing at the complex valley at the base of the Morse room chimney.

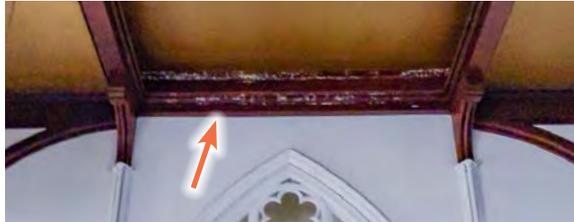
Image 136: Water damage is visible on the wood crown moulding, high above the west apse's pointed archway.

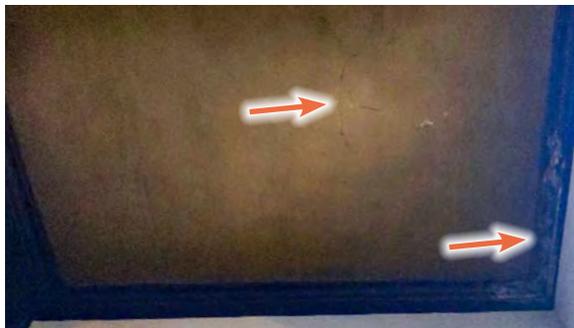
Image 137: The most active leak is above the northeast corner of the sanctuary, in the aisle.

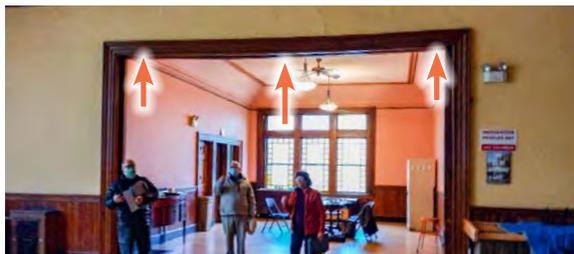
Image 138: The sagging header at the north parlor's monumental pocket doors should be inspected.

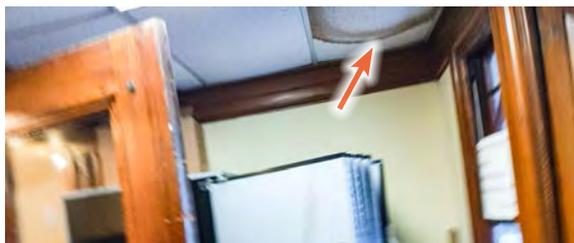
Image 139: Water damage in the Eliot street vestibule is indicative of the deteriorated copper roof above.
